Performance Degradation of Grid-Tied Photovoltaic Modules in a
Desert Climatic Condition

A Thesis Presented in Partial Fulfillment
of the Requirements for the Degree
Master of Science in Technology

ARIZONA STATE UNIVERSITY

December 2010

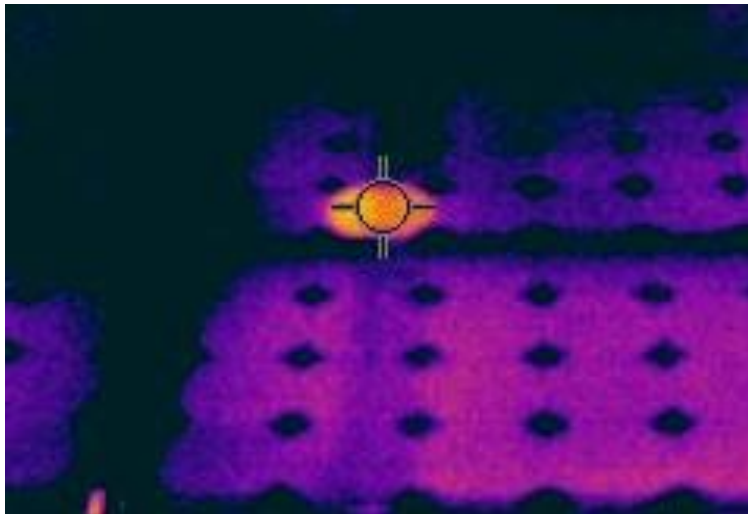
calibrated so the temperature given was not accurate however the temperature gradients obtained were accurate. This was checked using two thermocouples to measure temperature difference between the hot spot and non hot spot. The Figure 16 is an example of one of the modules found to be containing a hot spot.

Figure 16. Infrared image of hot spot cell in module

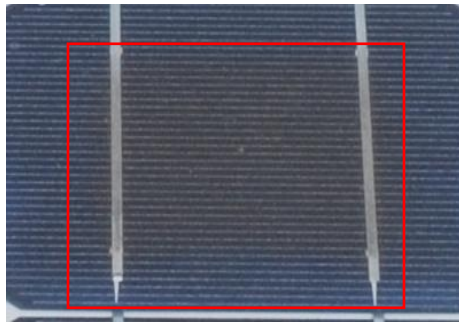
Browning of the encapsulant near the center of the cell was the most widely observed failure type at 89.1%. Encapsulant browning can have an effect on the power output. Figures 21 through 23 show the encapsulant browning in the center of the cells in Module A, B, and C.

Figure 21. Module A cell center browning

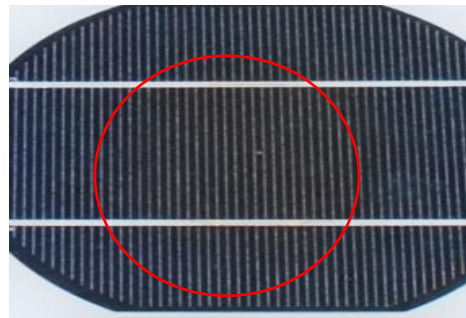
Figure 22. Module B cell center browning

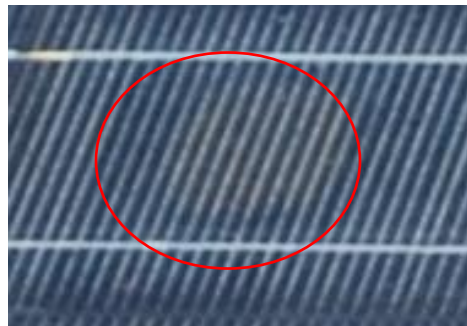
Figure 23. Module C cell center browning

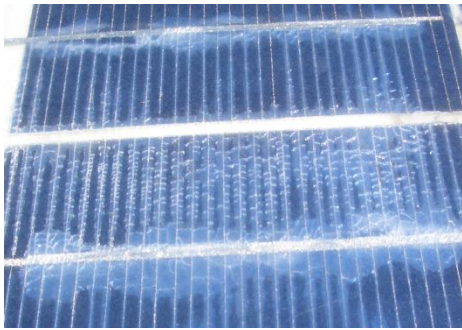
There were many cases of delamination of the encapsulant; however, they were confined almost totally to Model C, glass/glass modules. Model B experienced 2 cases of delamination spread over 1092 modules, a total of 0.18%. Model C however experienced 55 cases of delamination out of a total of 171 modules for a total of 32.16%. Model B has been fielded about two years longer and experienced only a small

fraction of the delamination of Model C. Figures 24 and 25 show relative severity of delamination found in Models B and C. Another noteworthy point is that Model A has been fielded about seven years longer than Model C and has zero cases of delamination.

Figure 24. Model C Delamination

The occurrence of older modules having less delamination than newer modules is believed to be rooted in the construction. Polymer backsheets such as the ones used in Models A, B, D, E, and F are able to maintain lower module temperatures as well as the laminates are breathable leading to oxidative bleaching of encapsulants. This reduction in exposure to high temperatures and increase in breathability are believed to reduce the occurrences of encapsulant delamination.

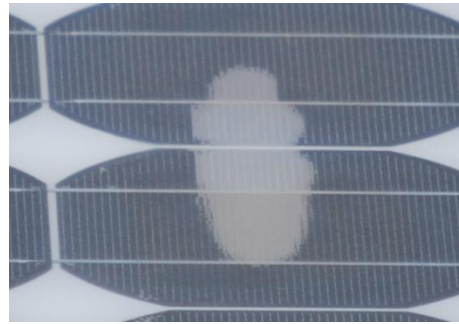
Figure 25. Model B Delamination

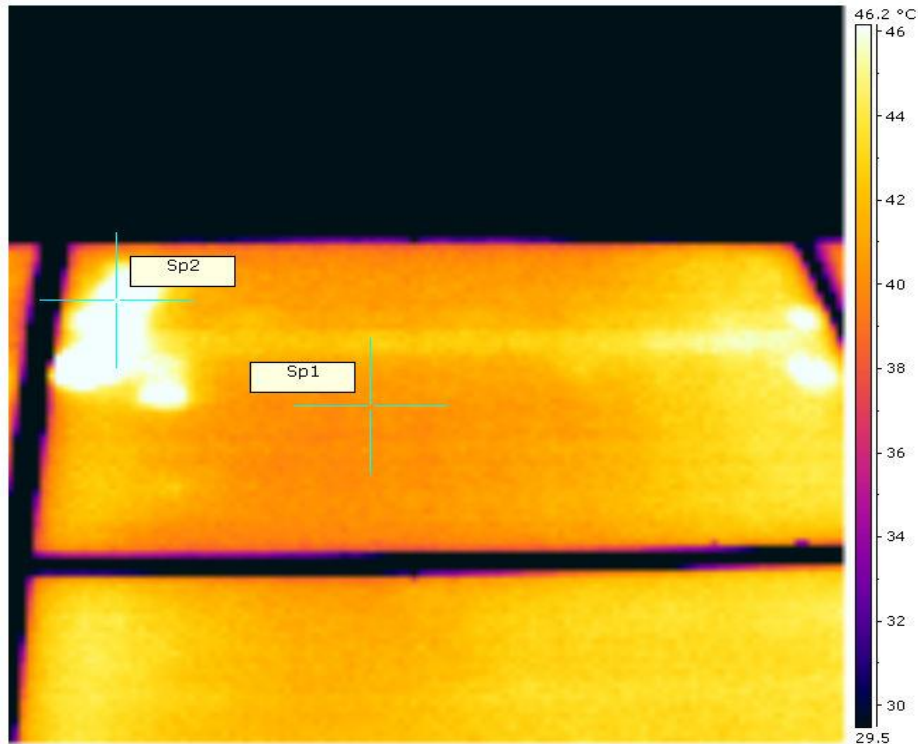
It is immediately obvious that Model C has the highest percentage of hot spots. It is believed that the thermal stress of the glass/glass construction and large size could be primary causes for this failure type. The second highest percentage of hot spots is found in Model D. Model D was also made of large size modules. As expected, the large size modules are more susceptible to thermal expansion and contraction of cell components including interconnects, superstrate/substrate and frames. Higher thermal expansion and contraction is expected to lead to higher hotspot issues.

The worst hotspot found was on a Model C module and had a temperature difference of 25.8 °C between the surrounding cells and the hot spot cells. Figure 27 show an infrared image of the model with the

Figure 27. IR image of Model C - most severe hotspot in sample

In the Figure 27 above, Sp1 was found to be the lowest temperature of the entire module with a cell temperature of 40.4°C while Sp2 was found to be the highest temperature with a cell temperature of 66.2°C.
