Performance Degradation of Grid-Tied Photovoltaic Modules in a
Desert Climatic Condition

A Thesis Presented in Partial Fulfillment
of the Requirements for the Degree
Master of Science in Technology

ARIZONA STATE UNIVERSITY

December 2010

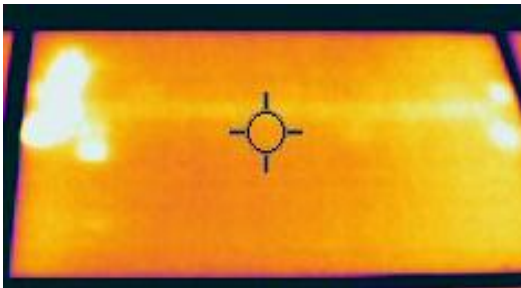
Figure 3. IR image of module hot spot

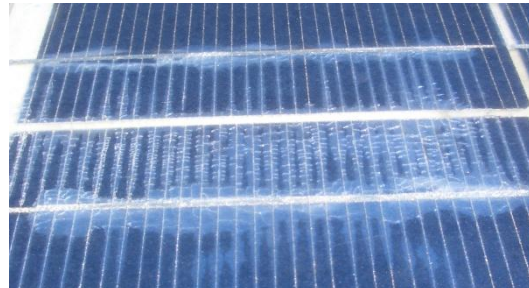
Figure 4. Delamination of encapsulant

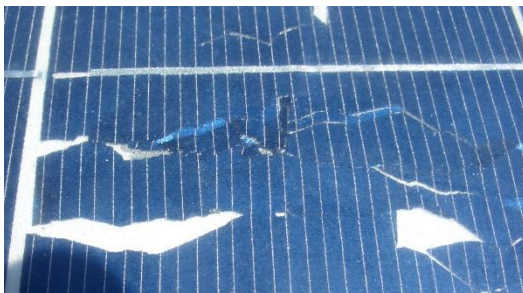
Figure 5. Shattered c-Si cell

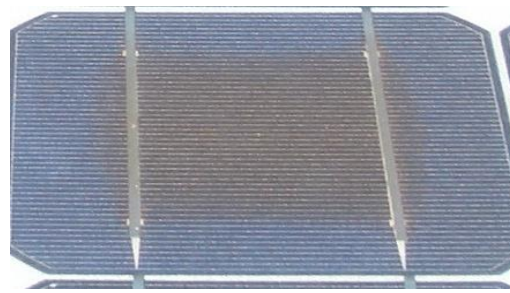
Figure 6. Browning of cell center

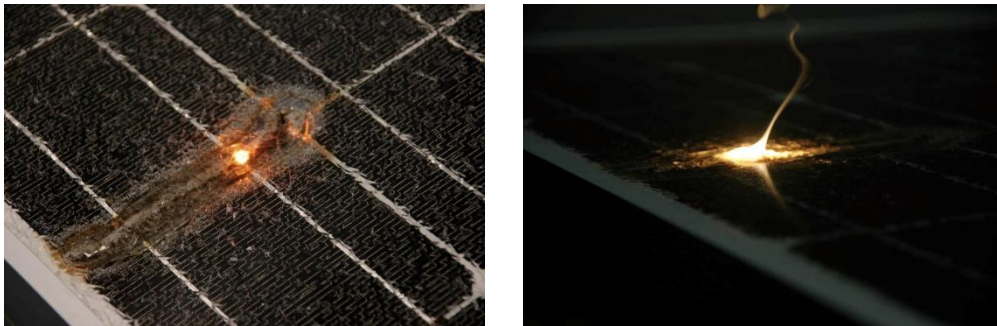
The loss of dielectric properties is not the only cause of DC arcing. Broken interconnects between cells can also establish the conditions necessary for a DC arc to form [13]. Images of DC arcing can be referenced in Figures 7 and 8.

Figure 7. DC arc under superstrate [12] Figure 8. DC arc burning through superstrate [12]

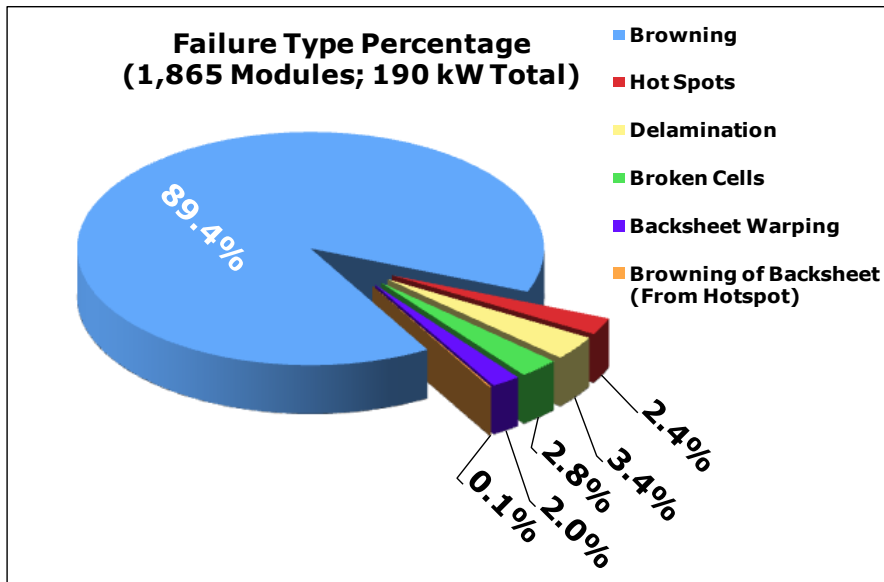
Figure 20. Failure type percentages out of 1,865 modules

Browning of the encapsulant near the center of the cell was the most widely observed failure type at 89.1%. Encapsulant browning can have an effect on the power output. Figures 21 through 23 show the encapsulant browning in the center of the cells in Module A, B, and C.

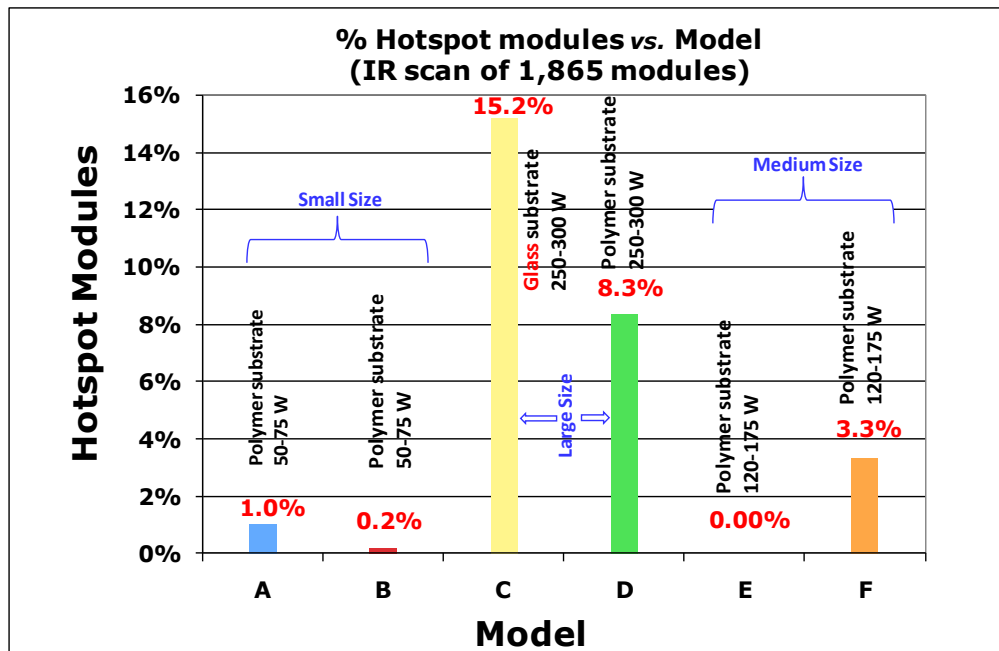
The infrared (IR) scanning of all 1,865 modules was performed to evaluate the presence and severity of hot spots. IR scanning under grid-tied condition was performed over sunny days with approximately 1,000 W/m² of irradiance. Due to concerns with time, modules were not short circuited in this scan. Scanning showed that there were 40 hotspot modules in the sample yielding a total of 2.2%. Figure 26 shows the total percentage of hotspot modules by model.

Figure 26. Breakdown of hotspot modules by model

(All are glass/polymer modules except “C” which are glass/glass modules)

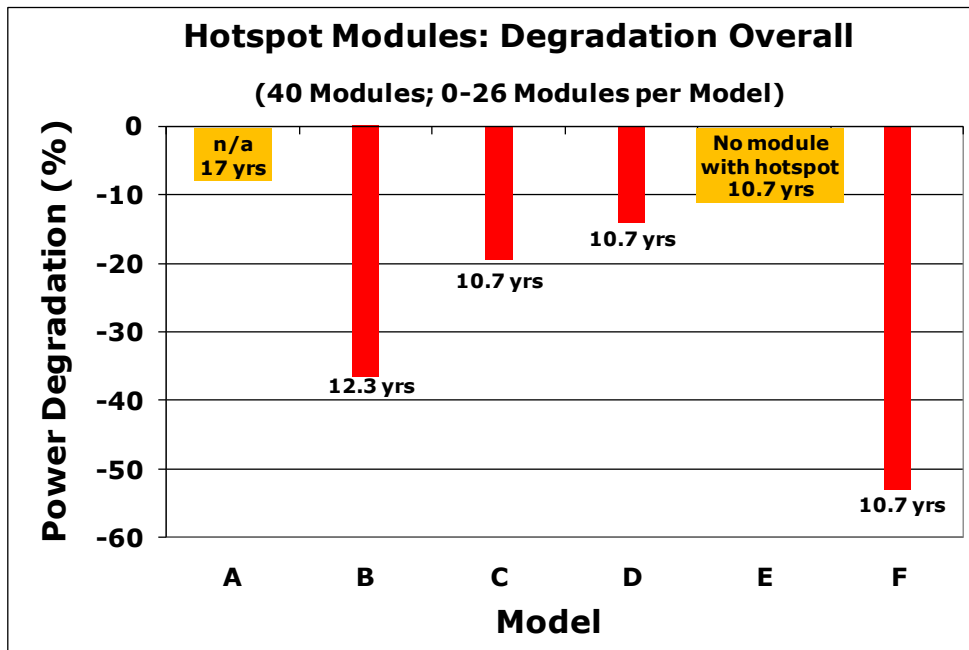
Figure 28. Degradation of hotspot modules (all years)

Figure 28 shows the average power drop from the nameplate rating of the models. There does not appear to be any discernable correlation between the age and extent of hotspots. The modules of Model C (10.7 years old) experienced about 15% (highest) hotspot occurrences and

about 19.5% power degradation whereas the modules of Model F (10.7 years old) experienced only about 3% hotspot occurrences but about 53% power degradation. This indicates that there is no direct correlation between hotspot severity, age, and power degradation unless the location/type of hotspot is sensitive to power generation issue (rather than safety issue). It seems that the hotspot modules of Model A are a special case. According to the data obtained from the I-V curve tracer, the power output of Model A had no power drop over the 17 years of fielding. Not knowing if it was human error during measurements by test personnel or labeling/binning (mixing higher power binned modules with lower power binned modules) by the manufacturer, it is felt that these findings deserve further attention and further study. These results will not be discussed in the remainder of this report.

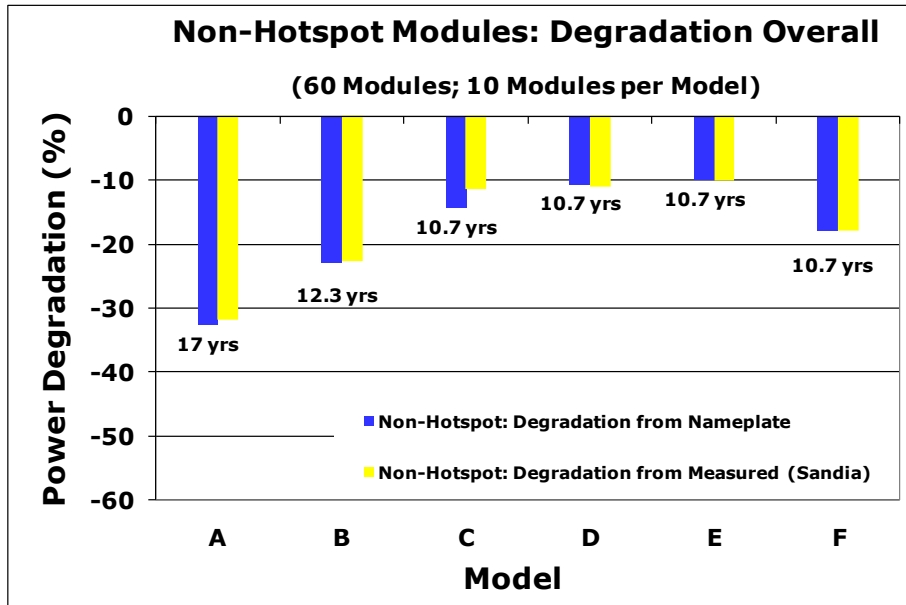
Figure 29. Degradation of non-hotspot modules (all years)

Figure 29 shows the average percent loss in power output of non-hotspot modules for each model in this study. For uniform comparison among the six models, all the modules considered in this performance degradation analysis were 1-axis tracker mounted modules excluding the fixed-tilt modules of Model A. All models had expected declines in power output, however, the magnitude of decline was surprisingly high. From this figure it becomes apparent that age is a primary factor in power loss amongst non-hotspot modules (about 98% of 1965 modules) – 12.3 and 17 years old modules, respectively, experienced about 23 and 33% power degradations; 10.7 years old modules experienced between 10 and 18% power degradations. From this figure, it is apparent that a large number of these fielded modules may not meet the commonly provided warranty requirements of less than 20% performance drop over 20-25 years. In the absence of initial performance data of all the modules tested in this project, the performance degradation calculations were performed assuming that the nameplate ratings of the manufacturers were accurate. In order to cross check if this assumption is valid, the performance degradations were calculated again with the data obtained from Sandia National Laboratories “Photovoltaic Module Database.” Sandia had, fortunately, independently measured and published the STC data of all these models and they were used in these calculations. As shown in

In the absence of intermittent performance data on the individual modules, the degradation rate of PV modules has been assumed to be linear. It is believed that as the module ages its annual degradation rate increases towards the end of its life. In Figure 29, one can see that the non-hotspot modules of older Models, A and B, have much higher annual degradation rates (1.9%) than that of the younger models C, D and E (1.3%). This could possibly imply that at some point during fielding the modules started aging at a more severe rate. However, the non-hotspot modules of Model F have degraded at much higher annual rate (1.7%) than its 10.7 years old counterparts (1.3%). This is possibly due to some design issues of Model F and these issues could be related to the inappropriate component selection, cell processing, cell interconnection and/or packaging. Table 4 shows degradation rates of each model by average percent drop per year. Again, one can observe that there is a noticeable increase in degradation rate between 10.7 years and the 12.3 or 17 years old modules. As discussed earlier, there does not appear to

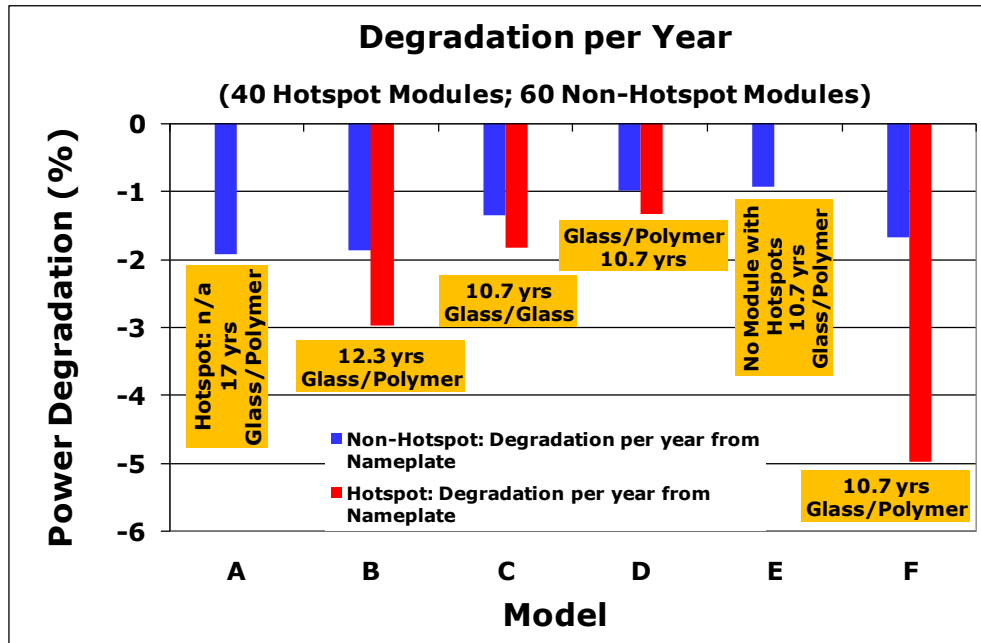
Figure 30. Degradation rate of hotspot and non-hotspot modules (per year)

To delve further into the annual degradation rates, one can notice that the annual degradation rates obtained in this study are higher than those previously reported. In a study performed by NREL [9] in Golden, Colorado, different modules were individually held at maximum power to study degradation. From the NREL and other module level long-term studies performed at ASU, it is seen that the crystalline silicon PV modules degrade at less than 0.5% per year. However, from the current study one could determine that c-Si modules degrade between -0.93% and -1.92% per year. This significant difference in degradation rate may lie in the system voltage levels, module mismatch and insolation levels (1-axis vs. fixed-tilt) of the systems investigated in this study.
