Combined UV-Temperature-Humidity Accelerated Testing of PV Modules:

Reliability of UV-cut and UV-pass EVA Encapsulants

A Thesis Presented in Partial Fulfillment
of the Requirements for the Degree
Master of Science

ARIZONA STATE UNIVERSITY

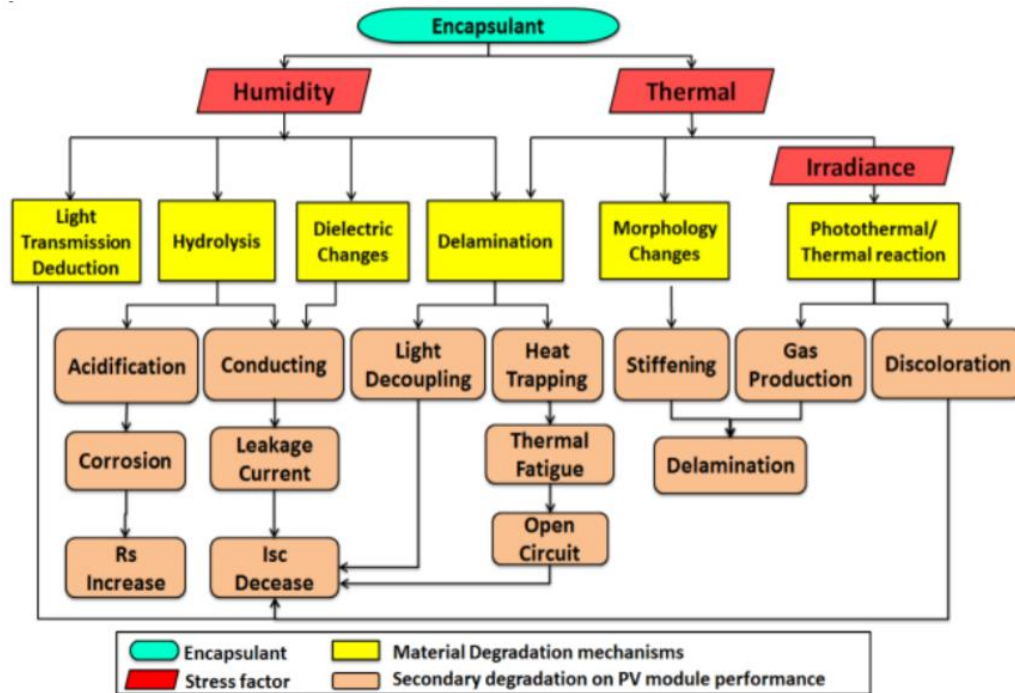
Figure 1.2: Impact of heat and humidity on the module components [3]

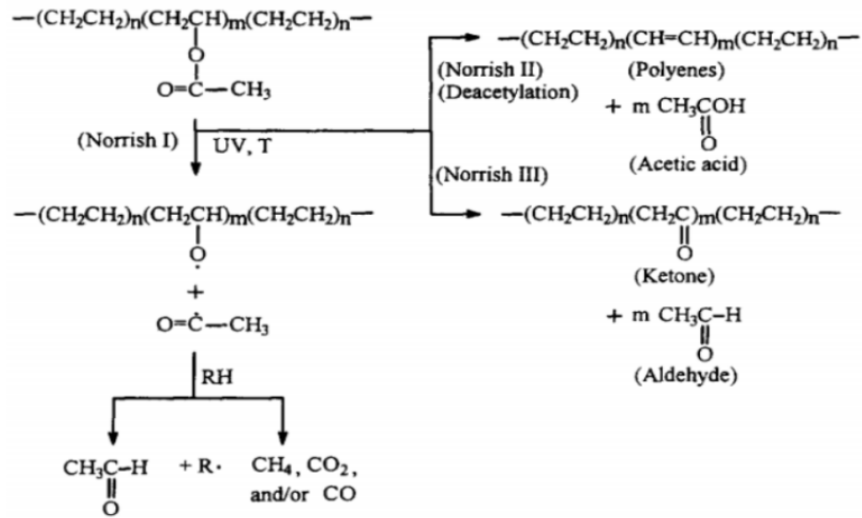
Figure 2.1: Degradation mechanisms in Ethylene Vinyl Acetate polymer under UV, Temperature [3]

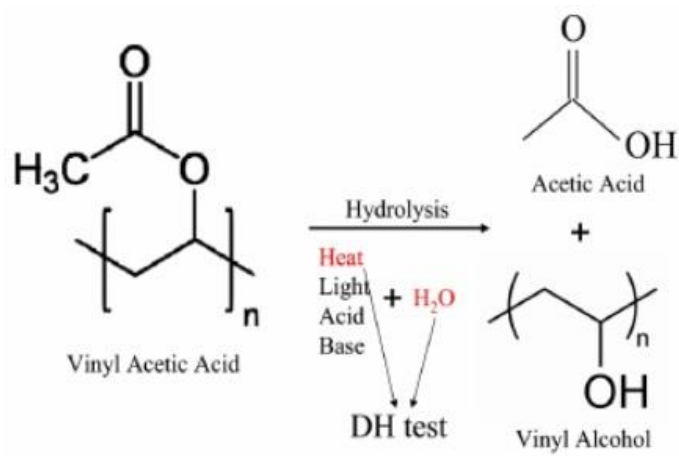
Figure 2.2: Degradation mechanisms in Ethylene Vinyl Acetate polymer under Heat and Humidity [11]

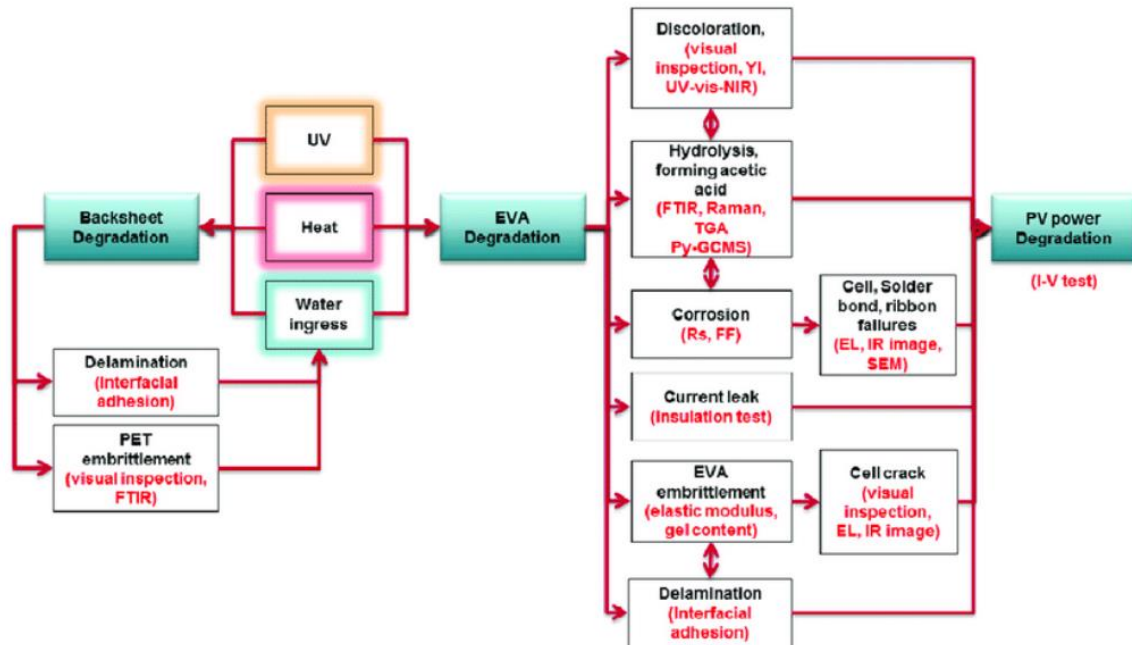
Figure2.3: Failure modes of PV modules caused by packaging materials and the evaluating approaches [14]

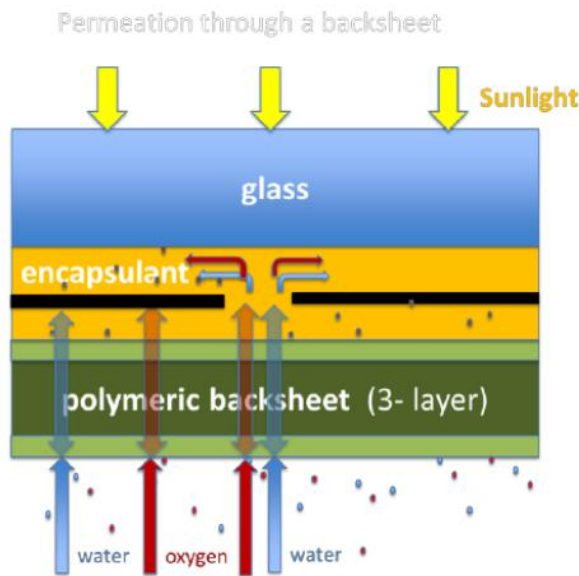
Figure 2.4 : Water and oxygen ingress path through the back sheet[16]

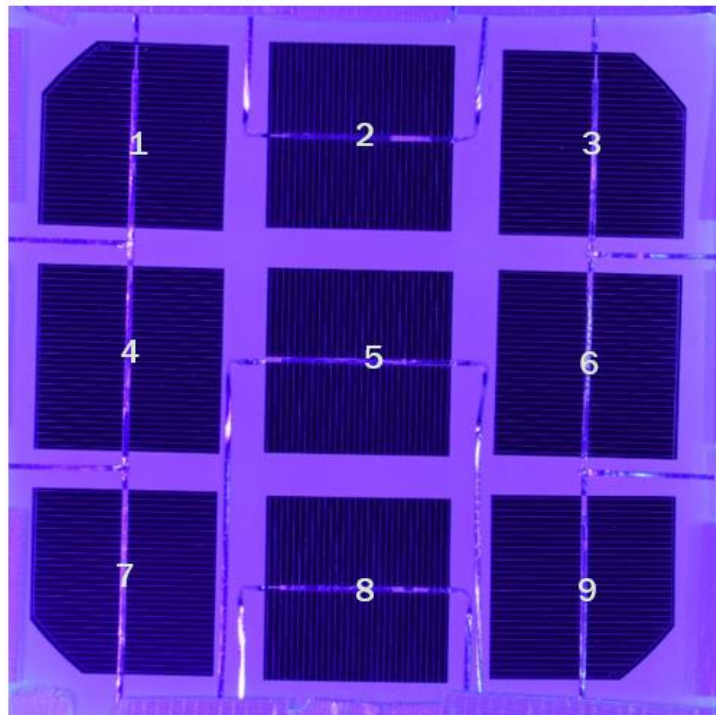
Figure 3.1: Cell numbering in the mini module

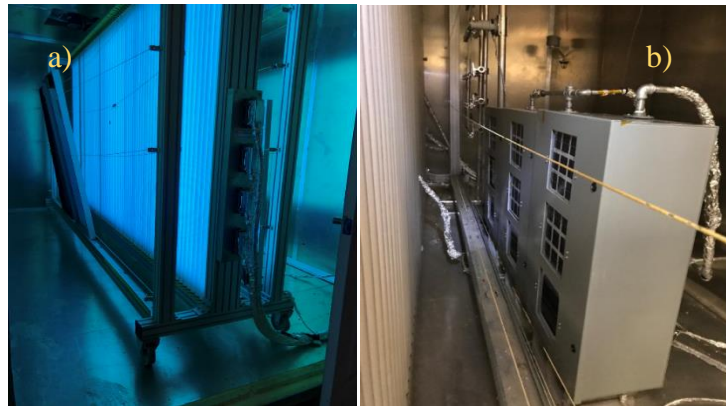
Figure 3.2:a) Inside view of alighted UV chamber b) RH box placed in front of the UV lamps

For the humidity testing in the UV chamber, six modules were used. Three modules of construction Glass/UV Cut EVA/solar cell/UV Cut EVA/Back sheet and three modules of construction Glass/UV Pass EVA/solar cell/UV Cut EVA/Back sheet construction (UV-Hybrid) were used. The back sheet is directly exposed to humidity/moisture and the front side to UV radiation as shown in *Figure 3.2*.

For the dry UV test, the modules were directly exposed to UV on the front side and the backsheet and edges of the laminate were covered with adhesive aluminum tape to avoid air/oxygen and water vapor transmission through the backsheet. Therefore, in this dry setup, EVA is exposed to only UV and temperature with no access to oxygen or humidity. The temperature of the module was measured by a T-type thermocouple attached to the back sheet directly behind the fifth cell of each module.

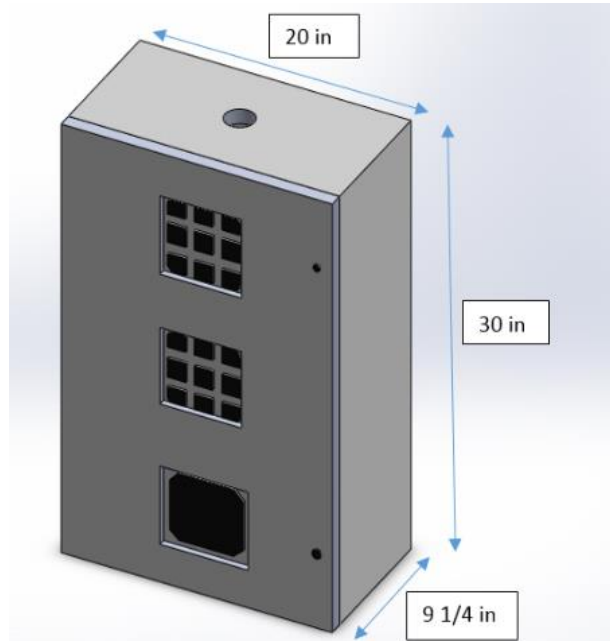
Figure 3.3: Dimensions of the box used for the UV-T-H testing (9-cell module testing shown in the top two windows and 1-cell dummy module testing shown in the bottom window; humidity is introduced through a hole shown on the top of the box)

The UV-T-H (UV-Temperature-Humidity) setup consists of a steam generator which delivers humidity in the form of low temperature steam inside a stainless-steel enclosure having a heating blanket and humidity sensor. The overall setup contains three enclosures to maintain three different temperatures. Each enclosure contains three windows and each window can accommodate one 9-cell module shown in *Figure 3.2*. In the current study, we needed only two windows (one for UV Cut EVA and the other for UV Hybrid EVA) and the third window was not needed. The third window was covered with a dummy 1-cell module to avoid the loss of humidity through the unused windows shown in *Figure 3.3*. Temperature is one of the three stressors used in the experiment and the other two stressors are UV and humidity. Three thermal blankets were used to maintain three different temperatures in the three enclosures as shown in *Figure 3.4*. The thermal blanket is kept at 9.25 inches from the 9-cell test modules. The required humidity and temperature inside the enclosure is maintained using a temperature and humidity controller along with a power supply as shown in *Figure 3.5* and *Figure 3.6*. The RH is monitored with humidity sensor HX 171 manufactured by OMEGA. The module temperature is monitored with a K-type thermocouple attached to the backsheet of each module at the center of the fifth cell shown in *Figure 3.1*. The data acquisition system collects the readings every ten seconds. Hence, in this setup, the UV light reaches the front side of the modules, and the back sheet is exposed to heat from the thermal blanket and humidity from the steam generator.

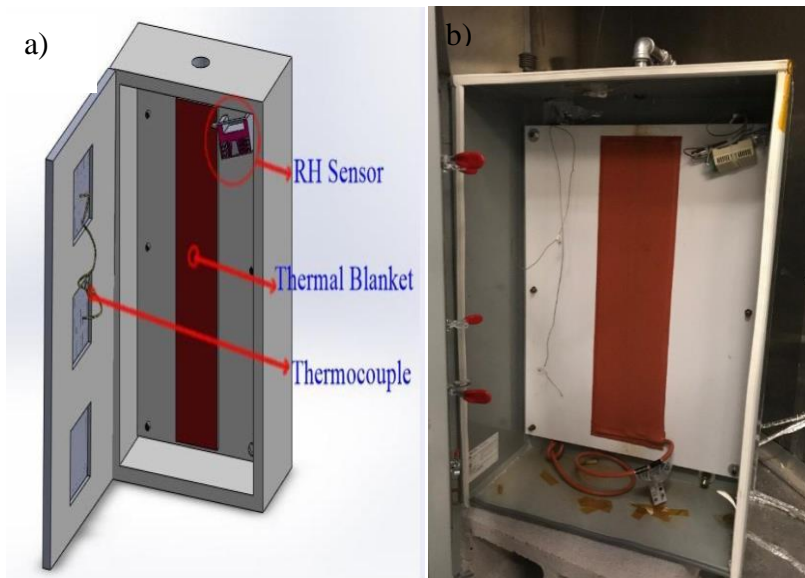
Figure 3.4:a)Components inside the T-H enclosure b) Photograph showing the location of heater and humidity sensor

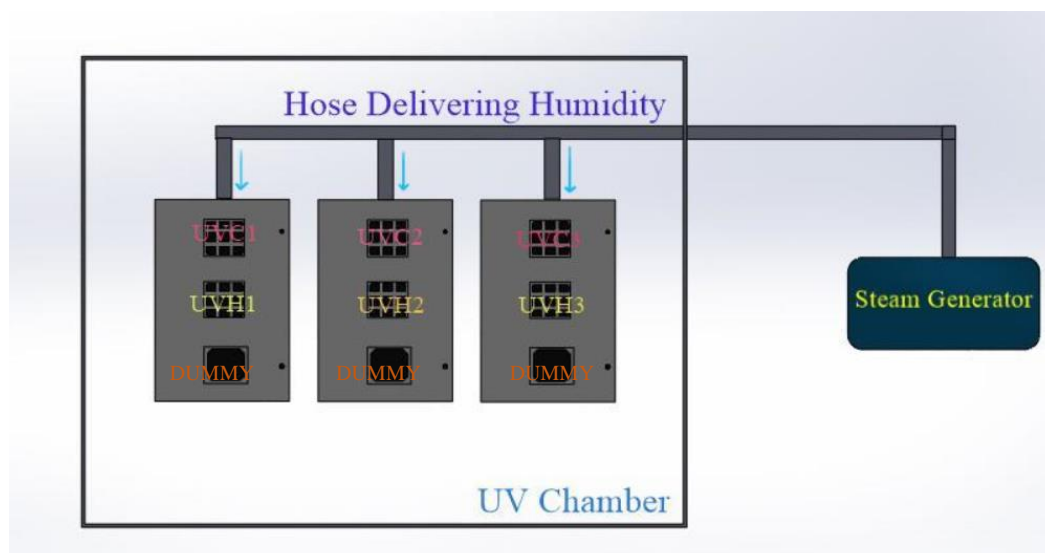
Figure 3.5: Front view of the setup inside the UV chamber

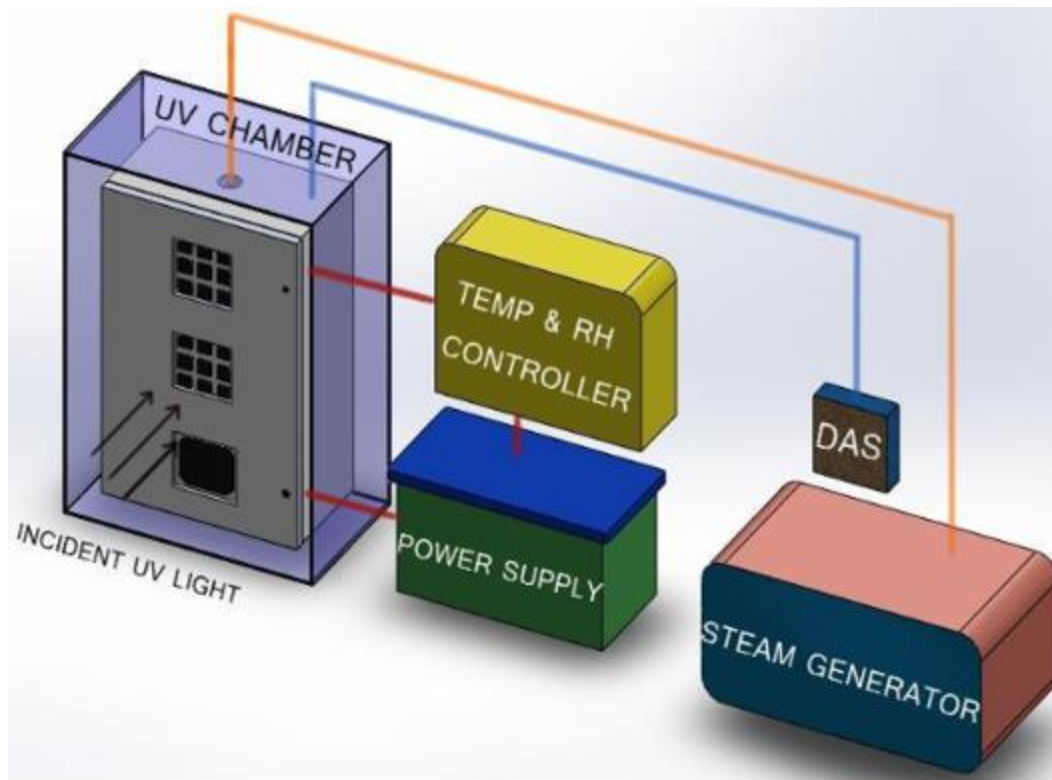
Figure 3.6: Combined UV-Temperature-Humidity Setup (the power supply used for the heaters and the DAS can be used to monitor the temperature of individual cells in each module)

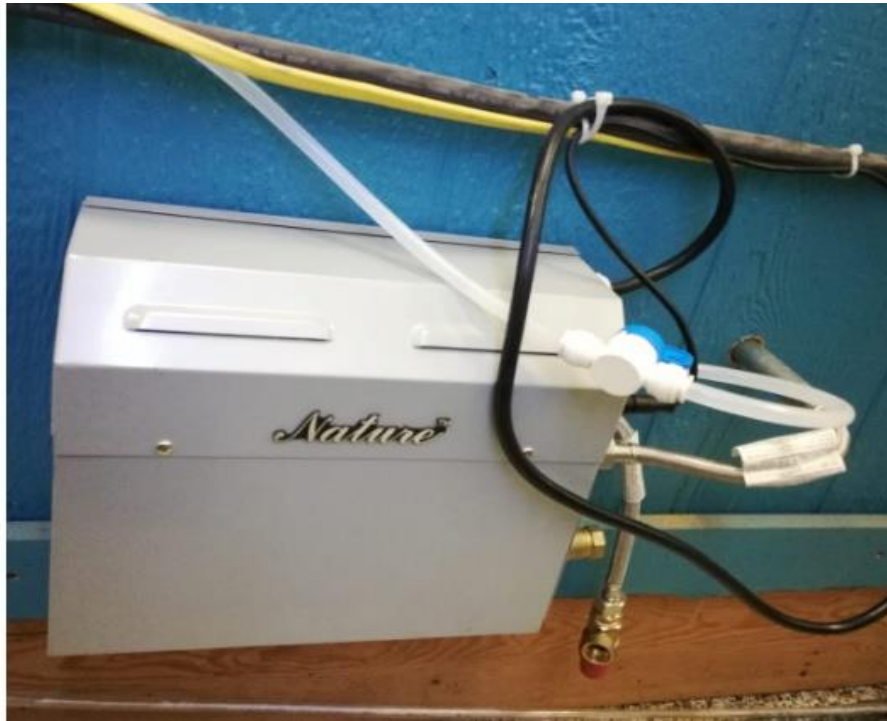
Figure 3.7: Steam generator for humidity delivery

When the steam generator is switched on, there is steady steam production after 9 minutes when it's filled fully with water. This is equipped with a water level sensor which fills in water once the level drops below the required level. For the project, the steam generator serves as the source of providing humidity, allows steam, from which the values of RH are recorded using the humidity sensor. Nature steam generator of the model NTA 20 from TOULE SAUNA INC was used.

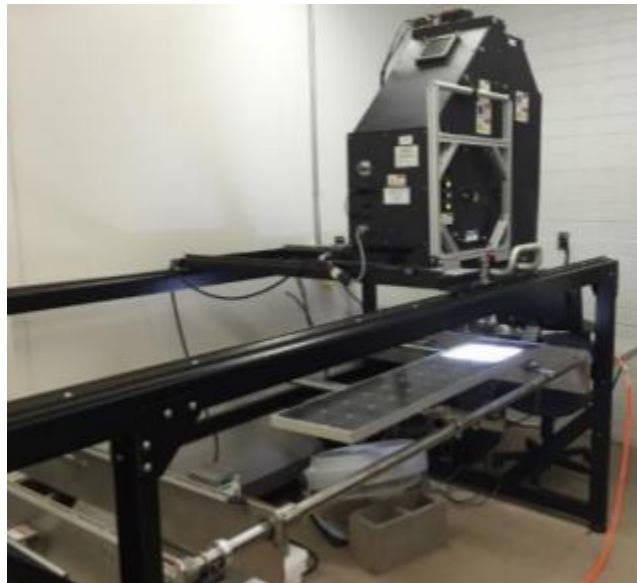
Figure 3.8: Solar simulator for indoor IV measurements

An indoor solar simulator is used for the IV measurements. The irradiance is calibrated using a PVM 798 reference cell. After the calibration, the test coupons are placed on the chuck. After opening the shutter, the light falls on the module of study. The measurements are taken for every test module through the ribbons coming out of each cell. From this, the value of short circuit current (I_{sc}) of each cell is found, which is the primary parameter of study in this project.

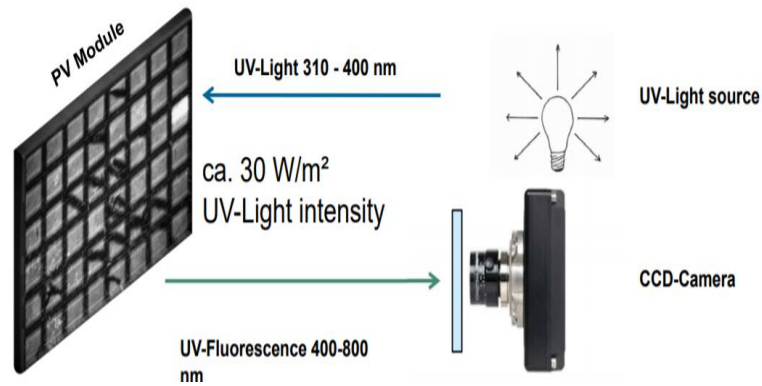
Figure 3.9: UVF imaging mechanism [21]

The UV-F imaging is used to detect the browning in the encapsulant much earlier than it can be recognized in the natural light. The imaging is done in the dark. The UV light is incident on the module of study from two arrays of UV lamps and the visible light thus

obtained from the test coupon is captured using a Nikon 3340 camera. The degraded molecules, i.e. the chromophores formed during the polymer degradation absorb the UV light incident, fluoresce and emit visible light which is longer than the wavelength of light absorbed. The fluorophore is a chemical compound which re-emits light on excitation and has aromatic groups or cyclic molecule with π bonds[20]. The setup provides uniform bright light on the module, and this technique offers fast characterization results.

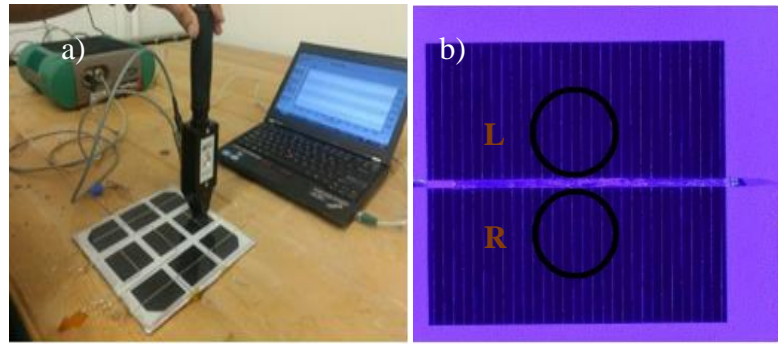
Figure 3.10:a) Reflectance measurement setup b) Positions in which the reflectance is measured

The amount of light reflected from the nine cell coupons is measured with a spectral radiometer. Before the data collection, the spectral radiometer is optimized. Optimization sets the proper settings for the light source which will be used to collect the spectra. The calibration is done on a white reference. The test coupons are measured for reflectance using a radiometer. The results are imported to the Viewspec Pro software and processed. Wavelength is plotted against reflectance in Origin after the processing.

The reflectance pattern for the UV cut module in dry conditions at 0 kWh/m² and 800 kWh/m² are shown below. The reflectance measurements are carried out on either side of the busbar (L and R) of each cell to increase the reliability of the results (*Figure 3.10*).

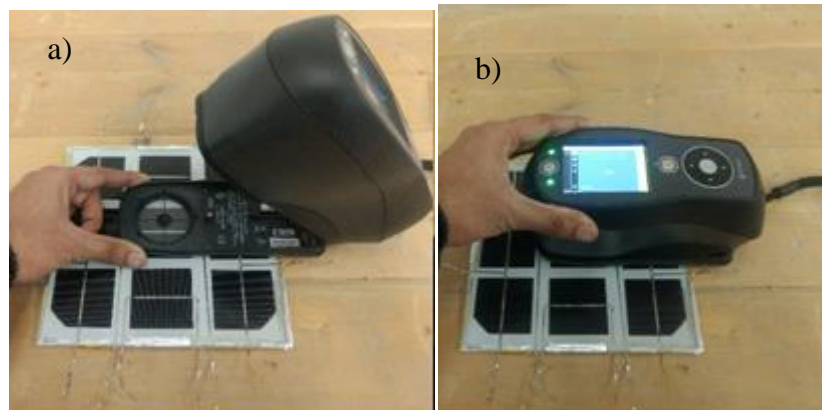
Figure 3.11:Colorimetry setup

The Xrite Ci 60 radiometer was used to measure the yellowness index. The PV modules have encapsulants which change their transmissive property over years of exposure. The encapsulants used in the PV modules start yellowing during field exposure. The YI measurements help to quantify the extent of yellowing in the PV modules. In this project, the measurements were helpful to quantify the change in the YI of encapsulants after exposure to combined stresses of UV, temperature, and humidity.

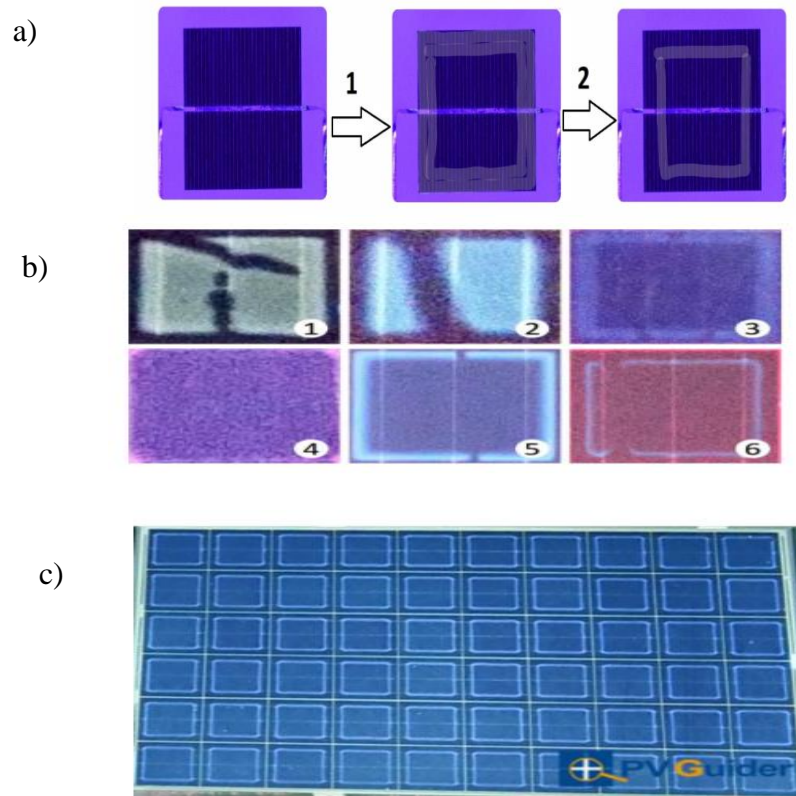
Figure 4.9: Possible mechanism of ring discoloration formation in a hybrid module (front UVpass and back UVcut) b) Discoloration pattern observed in solar fields in south eastern US[23] c) Module showing the ring pattern[24]

- 1) After the start of the experiment, there is both oxygen and humidity transport through the backsheet. Since the molecular weight of water vapor is lower than oxygen gas, it could diffuse faster through the backsheet and hydrolyze front EVA resulting in acetic acid production catalyzing the browning reaction of some additives in the front EVA (by Graham's law of diffusion the rate of diffusion is inversely proportional to the molecular masses). As a result, the encapsulant over the cell edges will be browned starting from the cell boundaries, and the discoloration pattern travels toward the center.

- 2) But, the competing bleaching reaction from oxygen diffusion occurs at a slower rate than water. Oxygen, when it permeates through the backsheet, bleaches the cell browned area on the periphery leading to ring formation. The diffusion rate of oxygen is not enough to ingress further into the cell area and thus bleach the discolored ring caused by moisture ingress. Hence the ring pattern is formed.

Figure 4.9: was reported by the southern company that modules with ring fluorescence were observed in the Southeastern US. They report no geographic dependence and it seems to be a phenomenon arising in younger modules (i.e. more recently manufactured and exposed for less time).

Multiple sites of various ages and manufacturers have been inspected. A subsample of results are shown in *Figure 4.9b*. Plants with older modules exhibit a square UVF pattern, while most younger modules exhibit a ring [23].

The *Figure 4.17* shows the ΔYI variation with for the UV hybrid coupons. The ring pattern was observed near the periphery and the area inwards from the ring was lightly discolored. The UV-Pass encapsulant was used in the front side. From *Figure 4.13* the UVP modules show negligible change in the value of ΔYI . But in this case the ΔYI is positive even at dosage of 200 kWh/m² dosage strongly supporting the phenomenon explained in *Figure 4.9*.

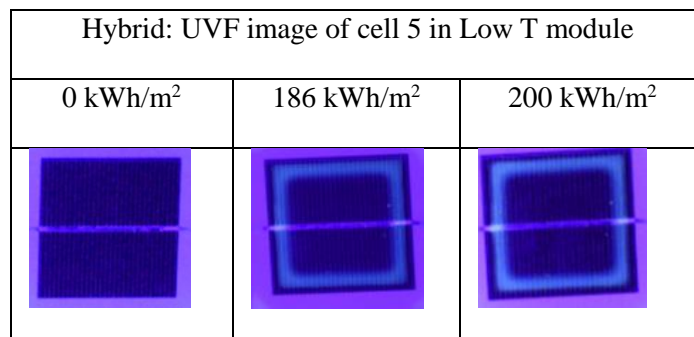
Figure 4.10: Close-up UVF image of cell 5 in Low T module at various dosage levels

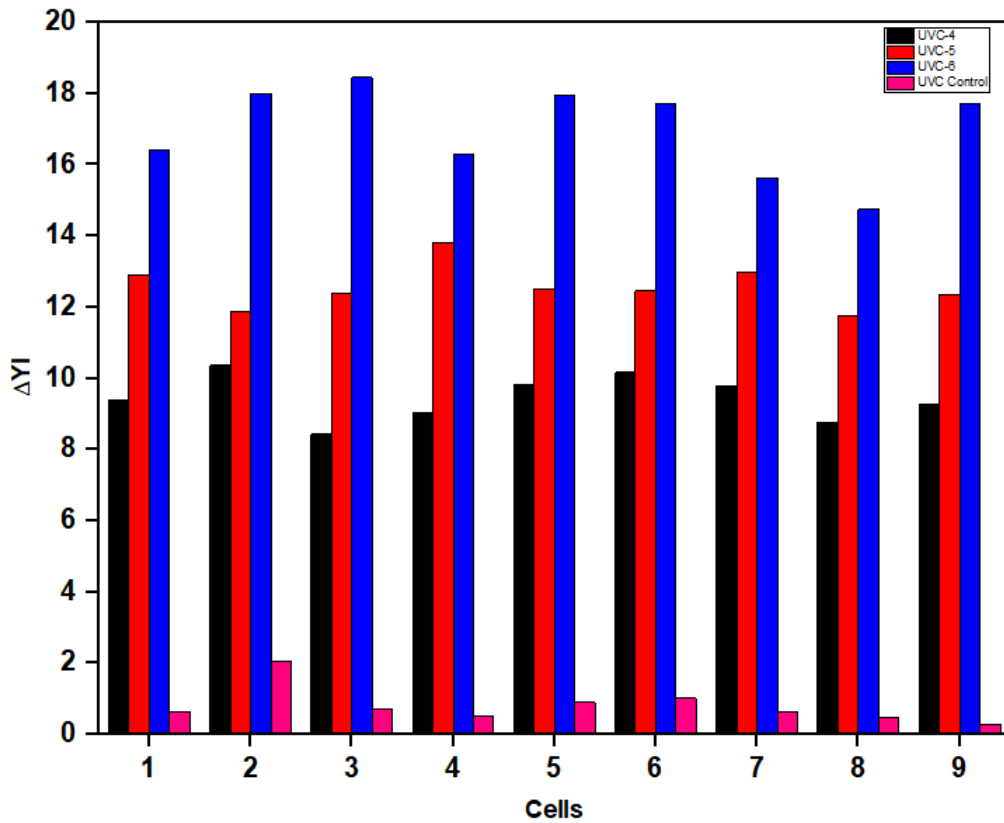
Figure 4.12: ΔYI of all cells for the UVC modules

The *Figure 4.12* shows the ΔYI values of the UV-Cut module in the dry run. From the graph below the decreasing order of ΔYI is $UVC6 < UVC5 < UVC4$. On correlating the UVF images with the YI measurements the greater the intensity of discoloration the greater the yellowness index. Also, the yellowness index increases with an increase in temperature with UVC-6 showing greater ΔYI .

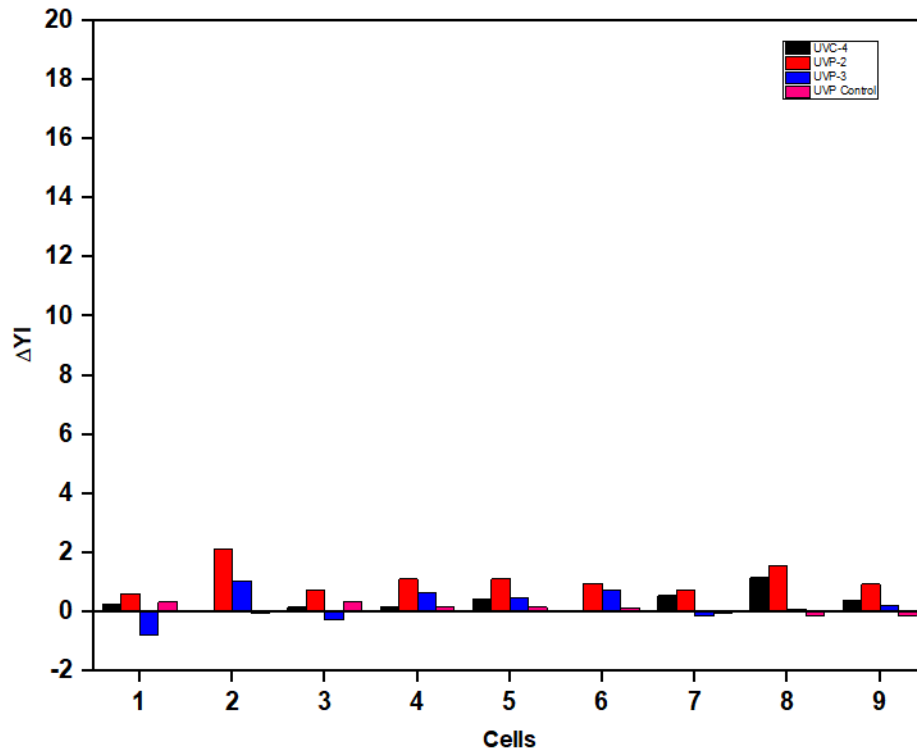
Figure 4.13: Δ YI of the all cells for the UVP modules

The *Figure 4.13* shows the ΔYI of the UV Pass modules. The change is ΔYI is negligible compared to the UV Cut modules. From the UVF images of the UV Pass coupons at 800 kWh/m² there was delamination with slight browning around periphery. The occurrence of light discoloration is supported from the positive values of ΔYI in some cells when compared to the negligible values of ΔYI for the control modules of UV Pass encapsulant.

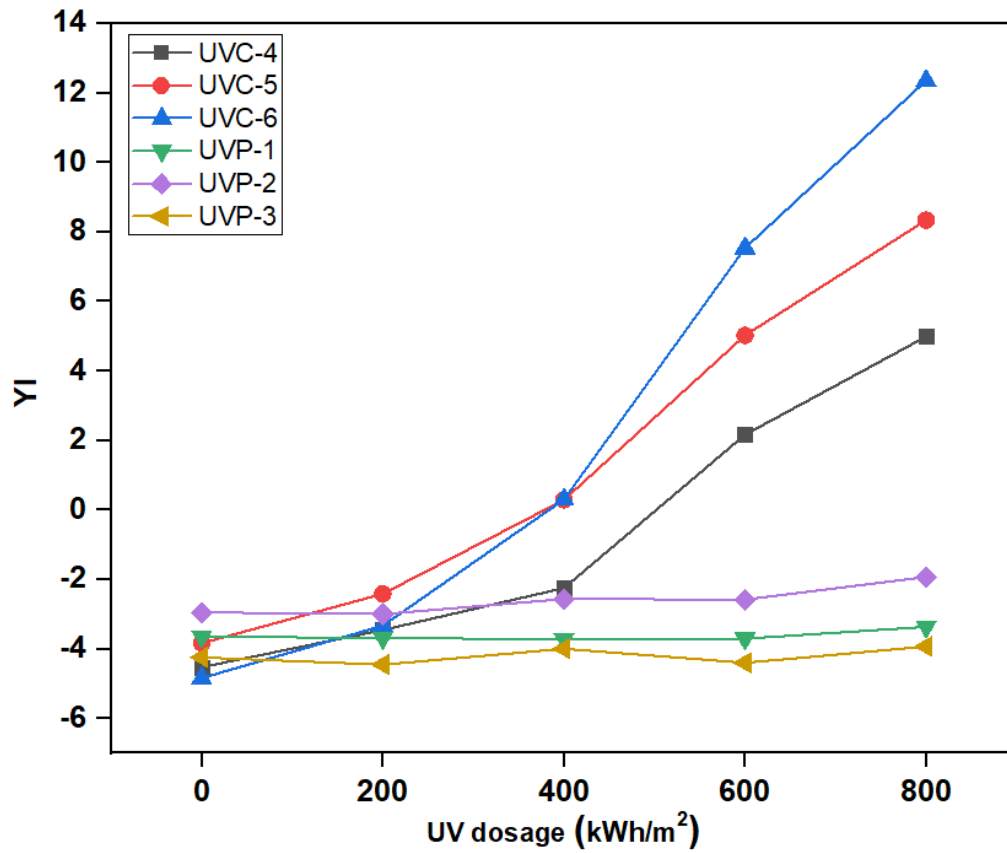
Figure 4.14: Change in average YI of the UVC and UVP modules with UV dosage

The *Figure 4.14* shows the variation of average YI of each module with the UV dosage. With increase in the UV dosage the value of average YI increases. This can be attributed to the formation of UV excitable chromophores which form on degradation of EVA with continuous UV dosage.

The variation of the average YI in the UV Pass module with the UV dosage is also shown in *Figure 4.14*. With increase in dosage there is no significant YI increase for the UVP modules because of lack of intense discoloration.

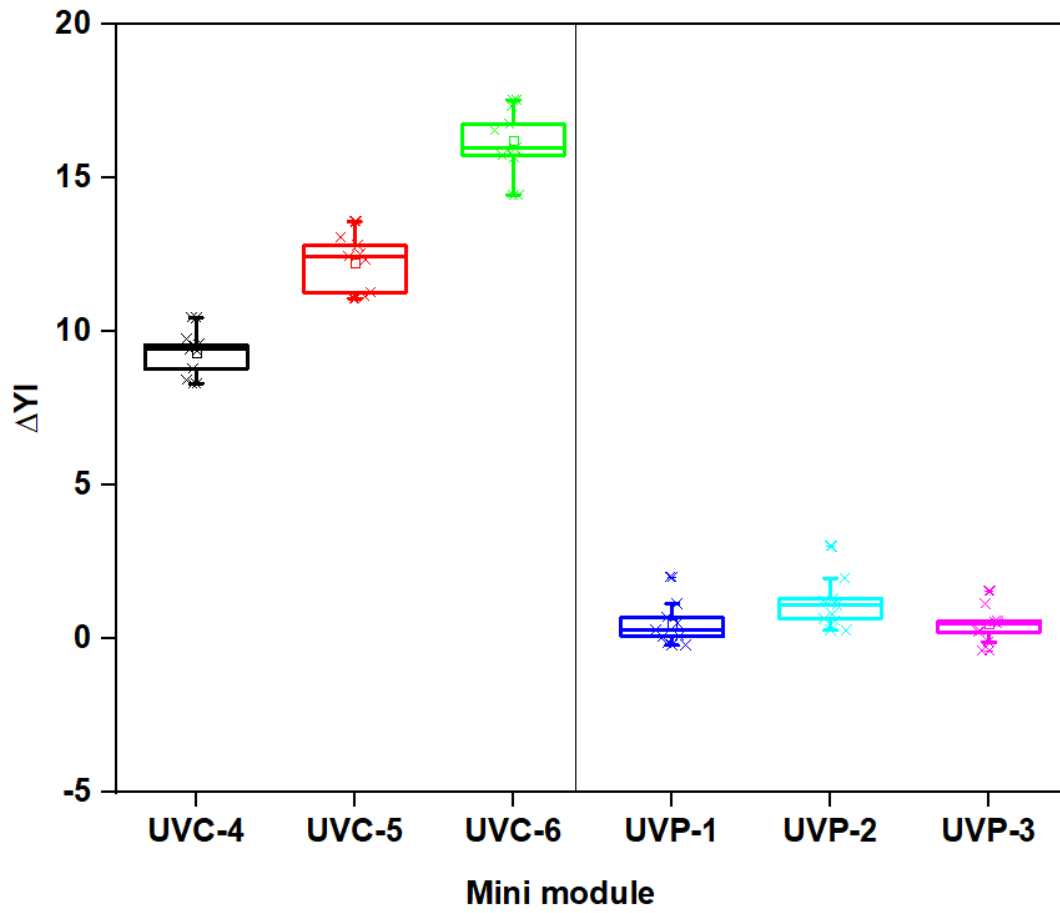
Figure 4.15: ΔYI of modules after 800 kWh/m² UV exposure in the chamber testing at low, mid and high temperatures.

The ΔYI increases with an increase in the module operating temperature for the UV cut modules. Since there is no yellowing in the UV Pass coupons the YI change is negligible and cannot be studied with temperature.

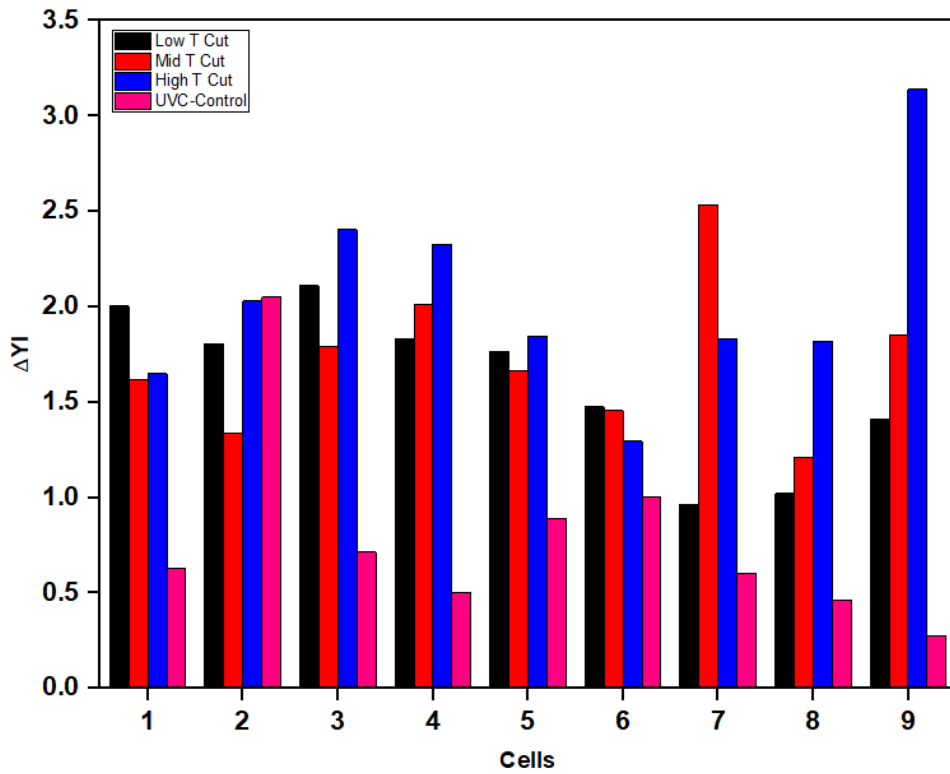
Figure 4.16: ΔYI of the all cells for the UVC modules in humid run

The *Figure 4.16* shows the ΔYI for the UV cut modules in the humid run. Three different temperatures were achieved. As discussed earlier, since the backsheet is permeable to oxygen and moisture, the discoloration changes according to the extent of diffusion of water and oxygen.

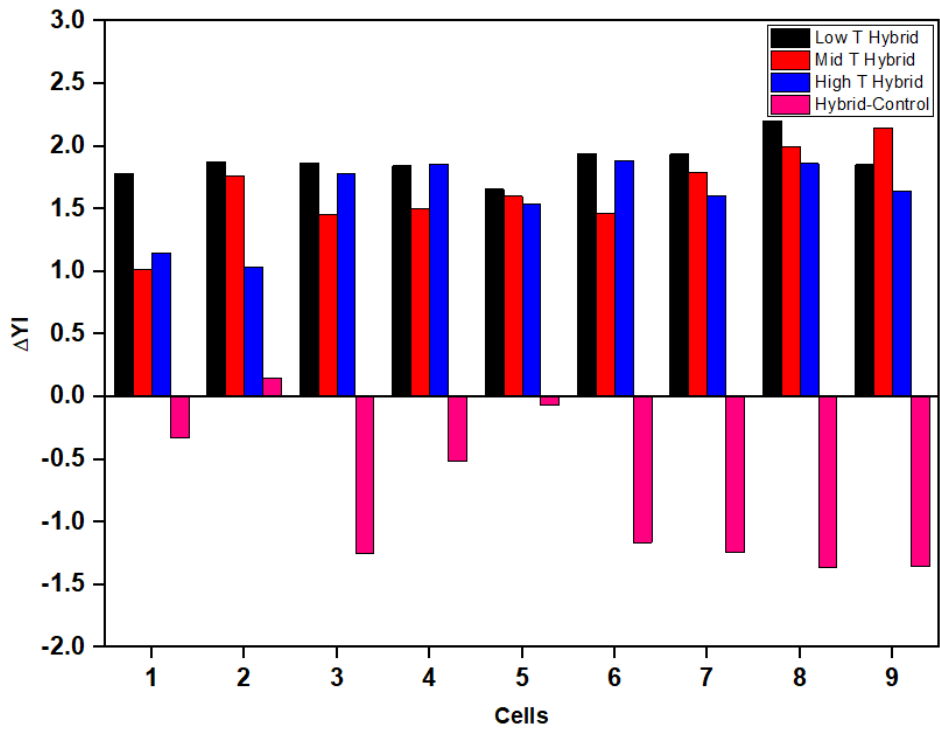
Figure 4.17: ΔYI of the all cells for the UVH humid coupons

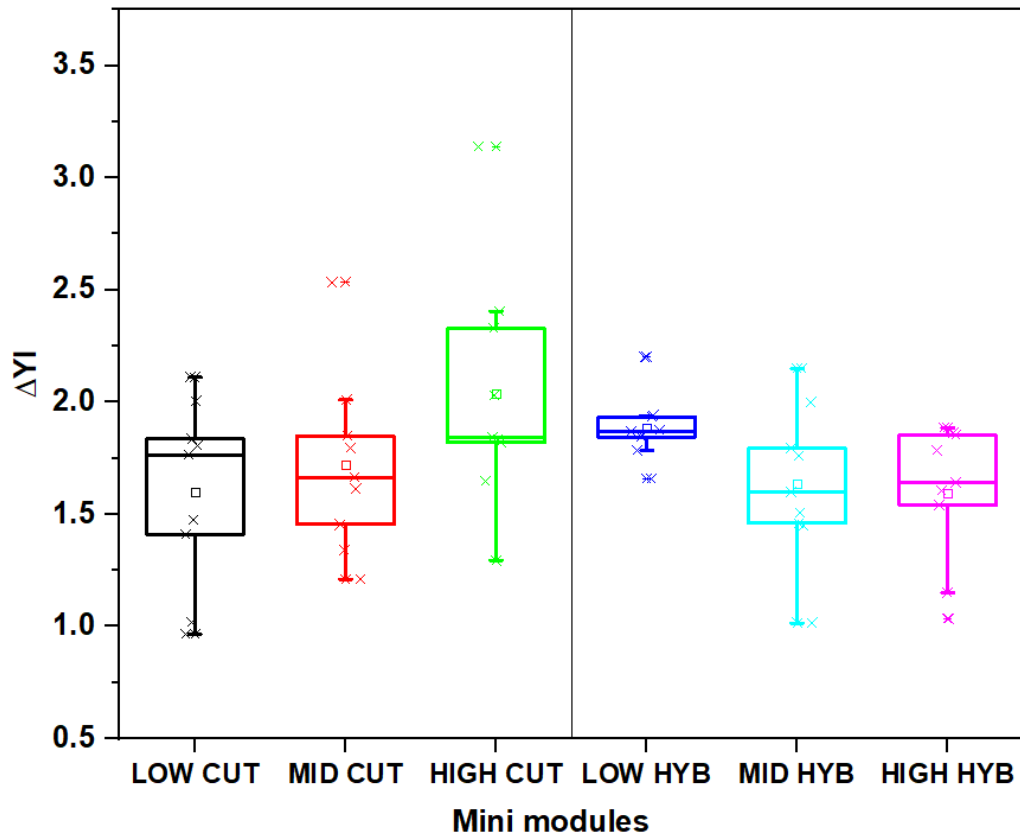
Figure 4.18: ΔYI of coupons after 200 kWh/m² UV exposure in the chamber testing at low, mid and high temperatures

From the *Figure 4.18*, a trend with temperature cannot be observed because of the combined effect of Temperature and humidity.

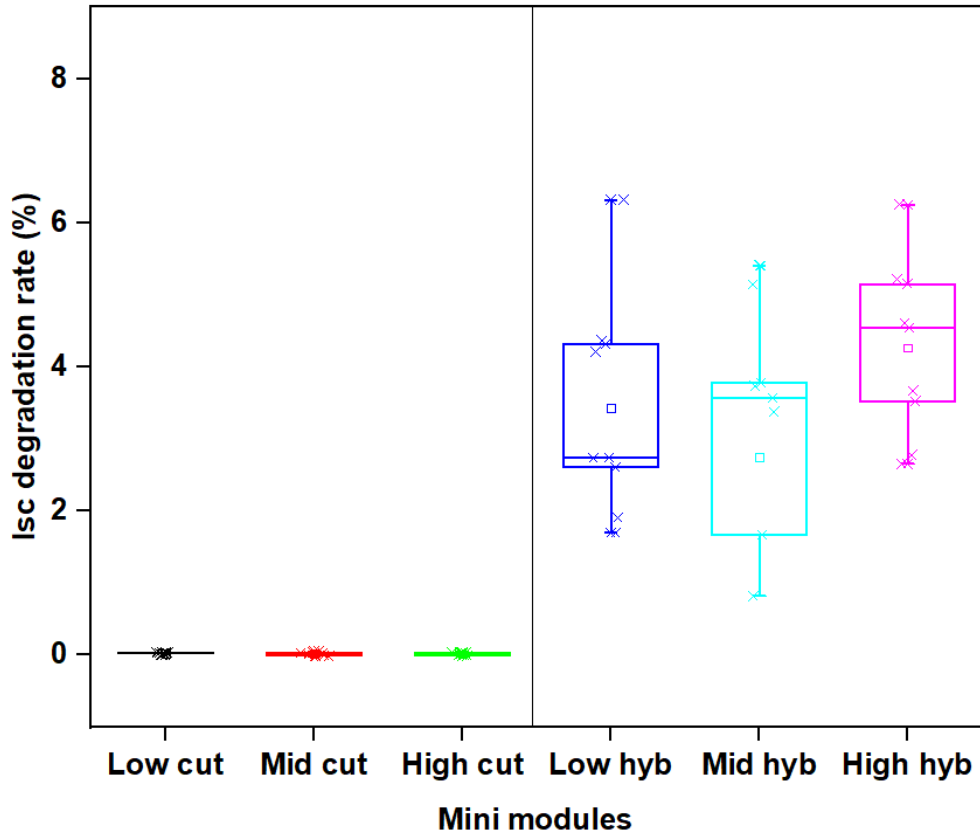
Figure 4.19: Change in the Isc degradation rate of the modules in the humid run

The IV measurements for the coupons are done using an indoor solar simulator. The measurements for the humid coupons were carried out at 0 and 186kWh/m². For the dry coupons it is carried out at 600kWh/m². The variation of the Isc degradation rates for different coupons is shown in *Figure 4.19* and *Figure 4.20*

In the humid run, the degradation of Isc is less than 1% for the coupons with UVC encapsulant. This shows that the light discoloration observed in the UVF imaging does not contribute to the Isc degradation. The Isc degradation of the UV hybrid coupons is higher than 2% showing the UV-Hybrid coupons might not be well suited for field applications. The drastic drop in the Isc of the UV-Hybrid modules might be because of the ring pattern showing it might be detrimental to the module performance.

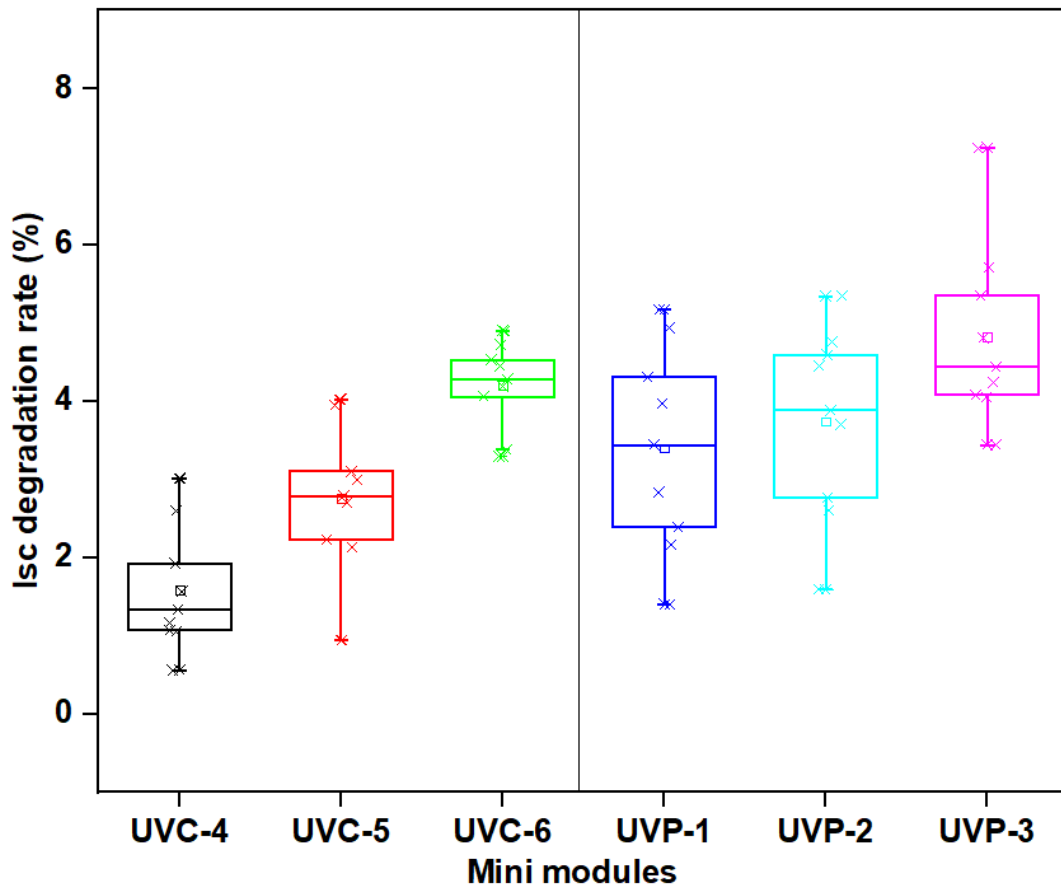
Figure 4.20: Change in the Isc degradation rate of the coupons in the dry run

In the dry run, for the UV cut modules browning was observed. Hence the Isc degradation observed is attributed to the reduction in transmission of the visible light due to browning. The degradation increases with increase in temperature. In the UV-Pass modules delamination was observed from the UVF images. The degradation in Isc of the UV-Pass coupons can be attributed to delamination and the initiation of light discoloration. Moreover, the change in YI is negligible but the Isc loss is drastic which could be possible due to delamination.

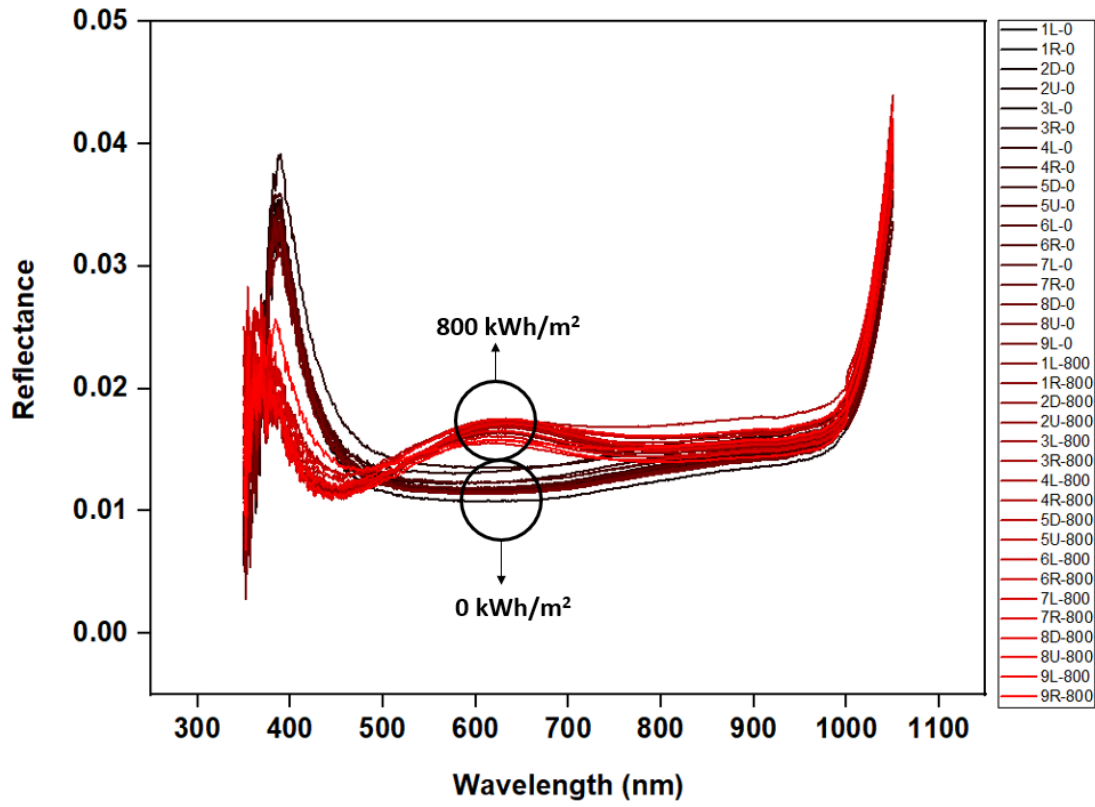
Figure 4.21: Reflectance plot for all cells in UVC-6 (dry run)

The spectral reflectance is high for the discolored EVA when compared to the module with fresh and unexposed EVA. This trend is more prominent at dosage from 450 nm to 800 nm. The increased reflectance is because of browning, reducing the visible light transmitted to the cell and thereby affecting the power[25]. This also indicates the degradation of the antireflective coating with the loss of UV absorbers.

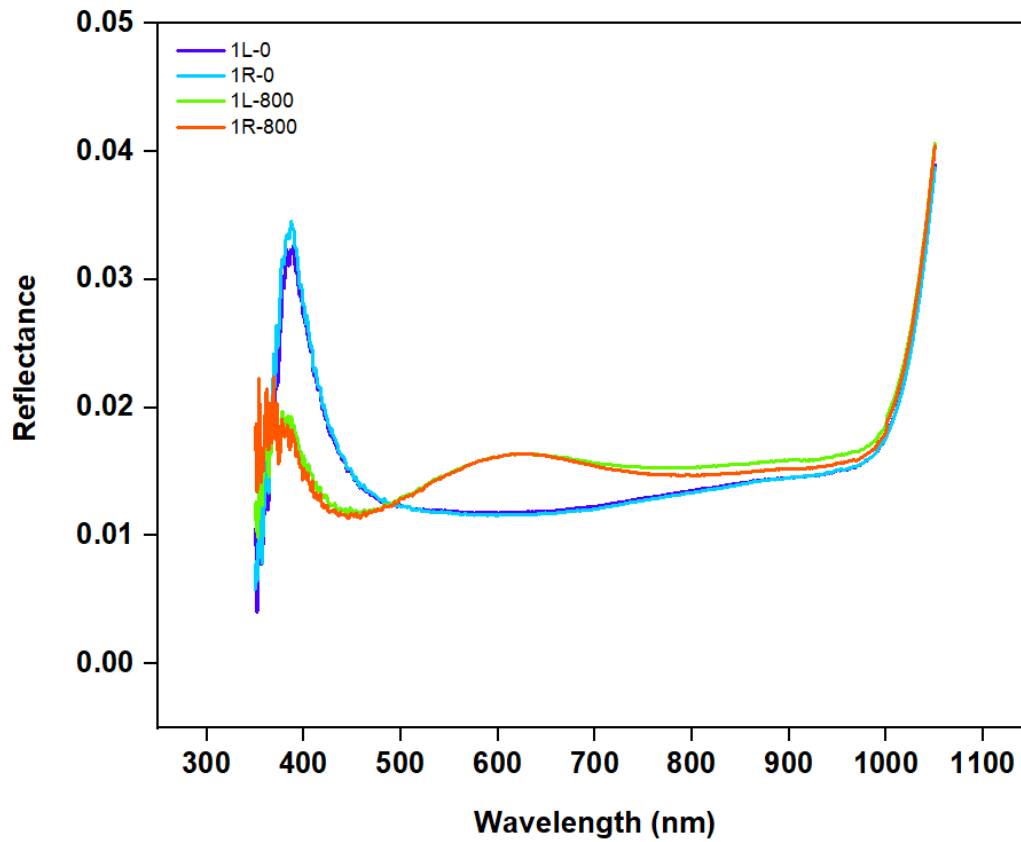
Figure 4.22: Reflectance for cell 1 at positions L and R of UVC-6 at 0kWh/m² and 800 kWh/m²

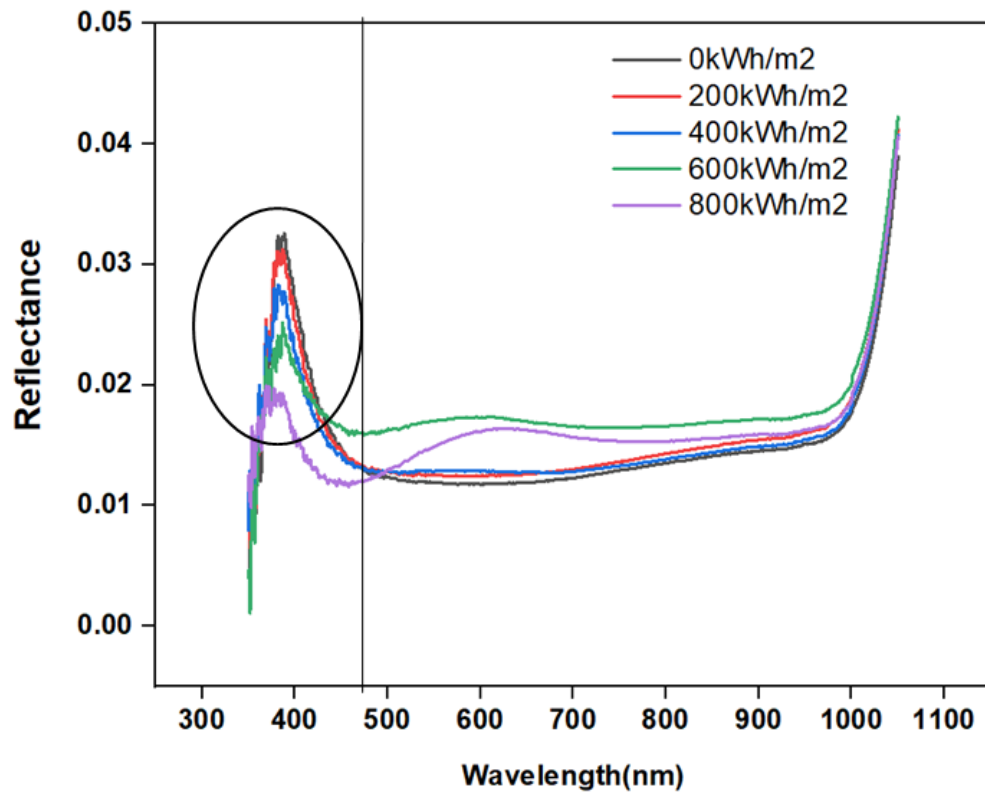
Figure 4.23: Reflectance study at 1L position from 350 nm to 400 nm of UVC6 (high T dry coupon)

However, reflectance of discolored EVA was lower than that of EVA without discoloration in wavelength 350–400 nm. That can be attributed to the loss of ultra violet absorbers in EVA with higher UV dosage[25]. This can also indicate that the antireflective coating of the module is more prone to UV damage with the loss of UV absorbers and hence results in increased reflection in the range of wavelength from 450 nm to 1100 nm.
