Combined UV-Temperature-Humidity Accelerated Testing of PV Modules:

Reliability of UV-cut and UV-pass EVA Encapsulants

A Thesis Presented in Partial Fulfillment
of the Requirements for the Degree
Master of Science

ARIZONA STATE UNIVERSITY

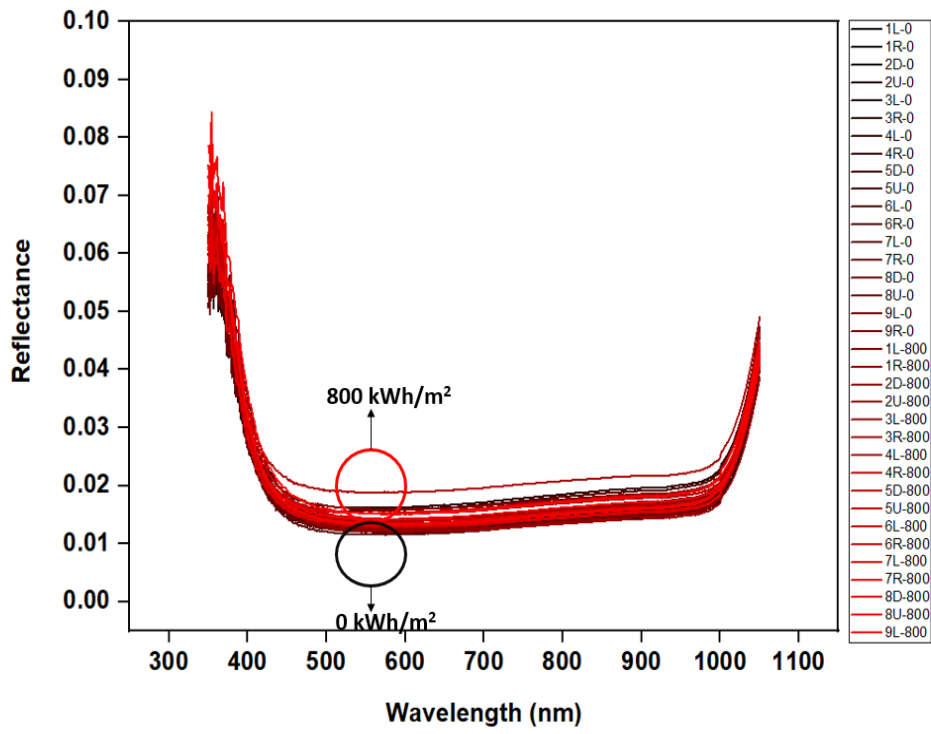
Figure 4.24:a) Reflectance plot for all cells in UVP-2 (dry run)

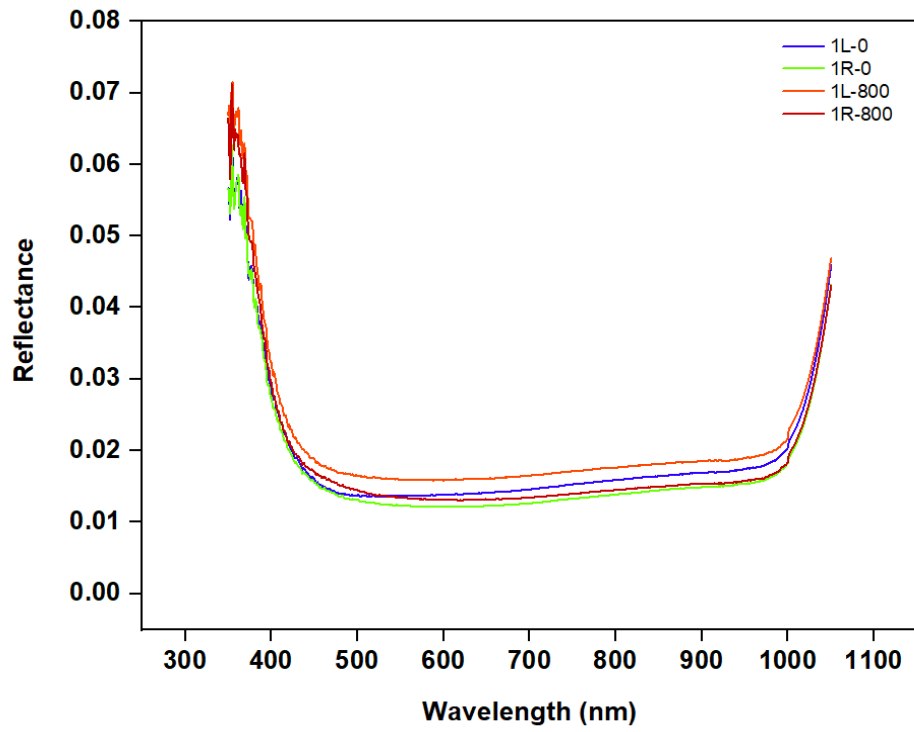
Figure 4.25: Reflectance for cell 1 at positions L and R of UVP-2 at 0 kWh/m² and 800 kWh/m²

Delamination is a major problem because it can lead to two effects: light decoupling where reflection increases. The reflectance at 800 kWh/m² is higher than the reflectance at 0 kWh/m² which is due to increased reflectance as shown in *Figure 4.25*[25].

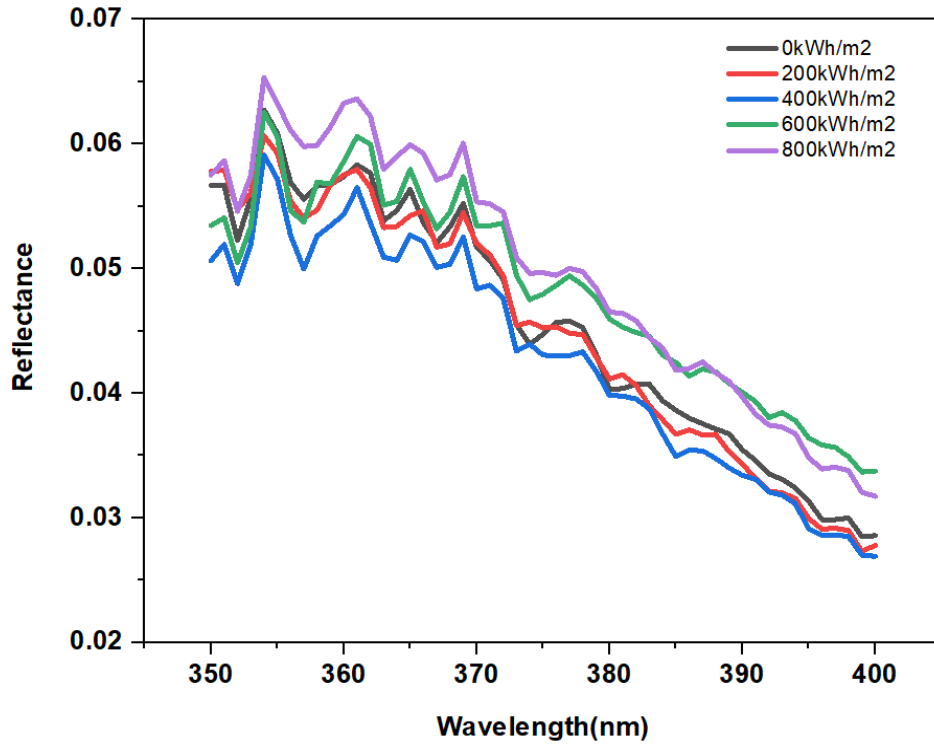
Figure 4.26: Reflectance study at 350 nm to 400 nm of the UVP coupons at 1L. At wavelength 350 – 400 nm, with higher dosage the reflectance is higher which is due to the lack of UV absorbers and hence the reflection is higher unlike in the case of the UV cut modules in the same wavelength range.

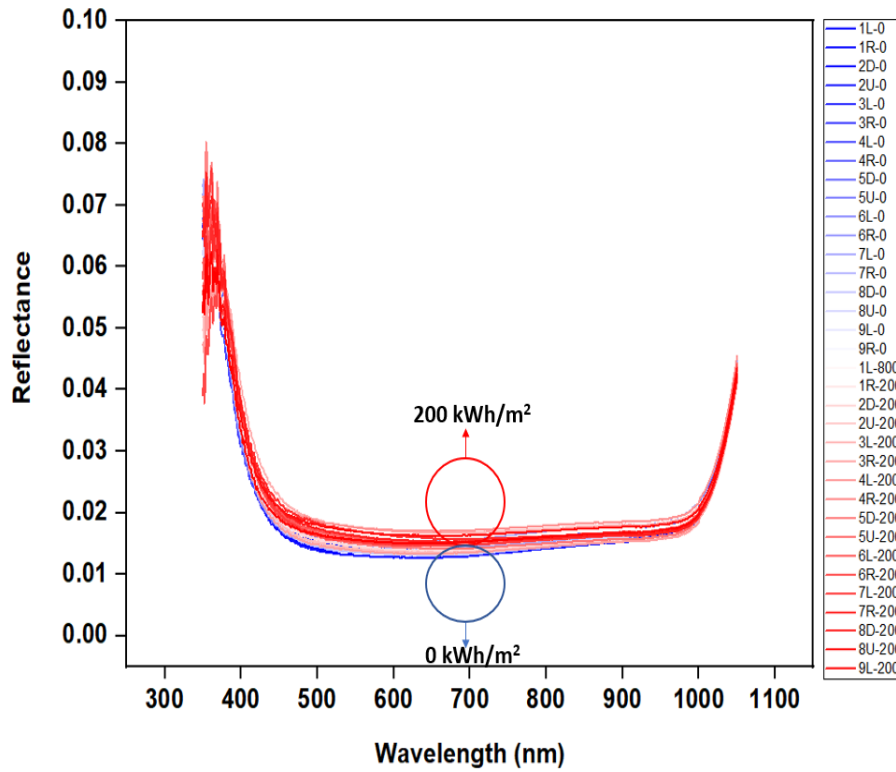
Figure 4.27: Reflectance plot for all cells for UV-Cut 0 kWh/m² and 200 kWh/m² (with humidity and oxygen)

Figure 4.27 shows the reflectance of the UV cut module exposed to UV, temperature and humidity. The modules at 200 kWh/m² showed a higher reflectance than the modules which were unexposed before the test as shown in Figure 4.27.

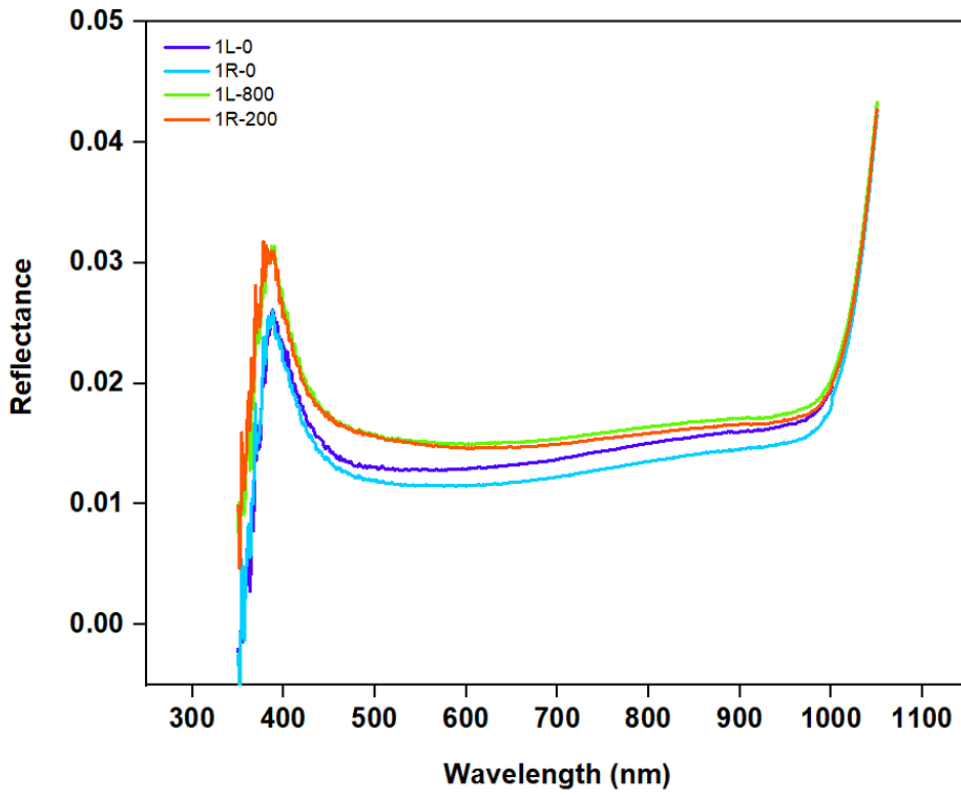
Figure 4.28: Reflectance for cell 1 at positions L and R of at 0 kWh/m² and 200 kWh/m² of high T humid cut module

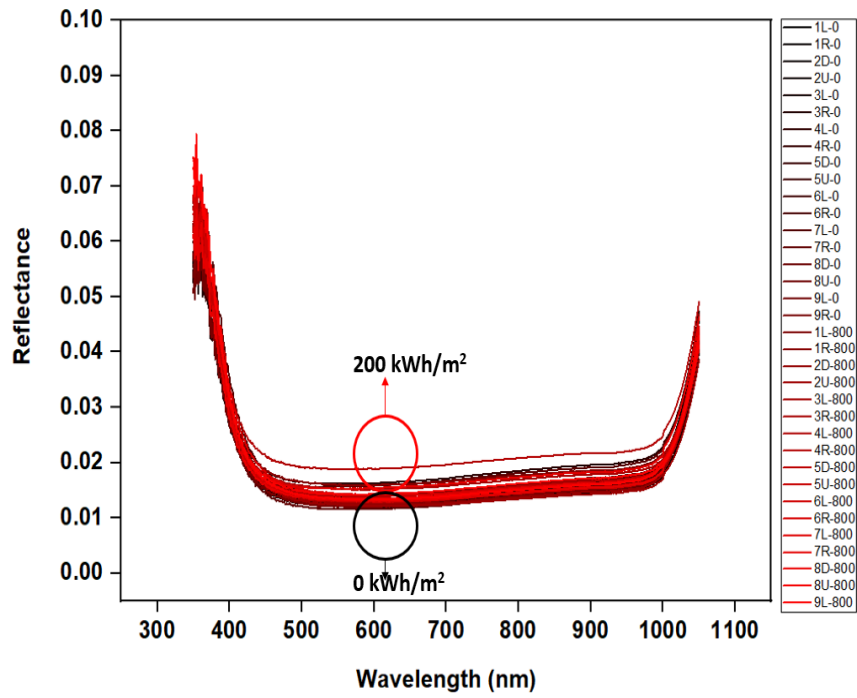
Figure4.29 : Reflectance plot for all cells in UV-Hybrid modules at 0 kWh/m² and 200 kWh/m² (with humidity and oxygen)

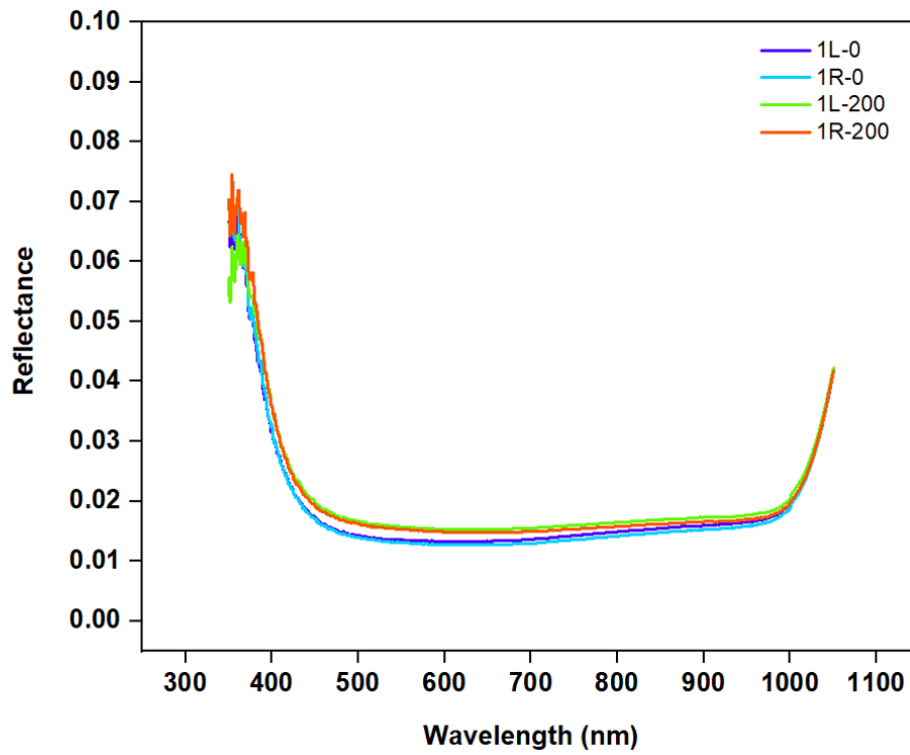
Figure 4.30: Reflectance for cell 1 at positions L and R of low T UVH at 0 kWh/m² and 200 kWh/m²

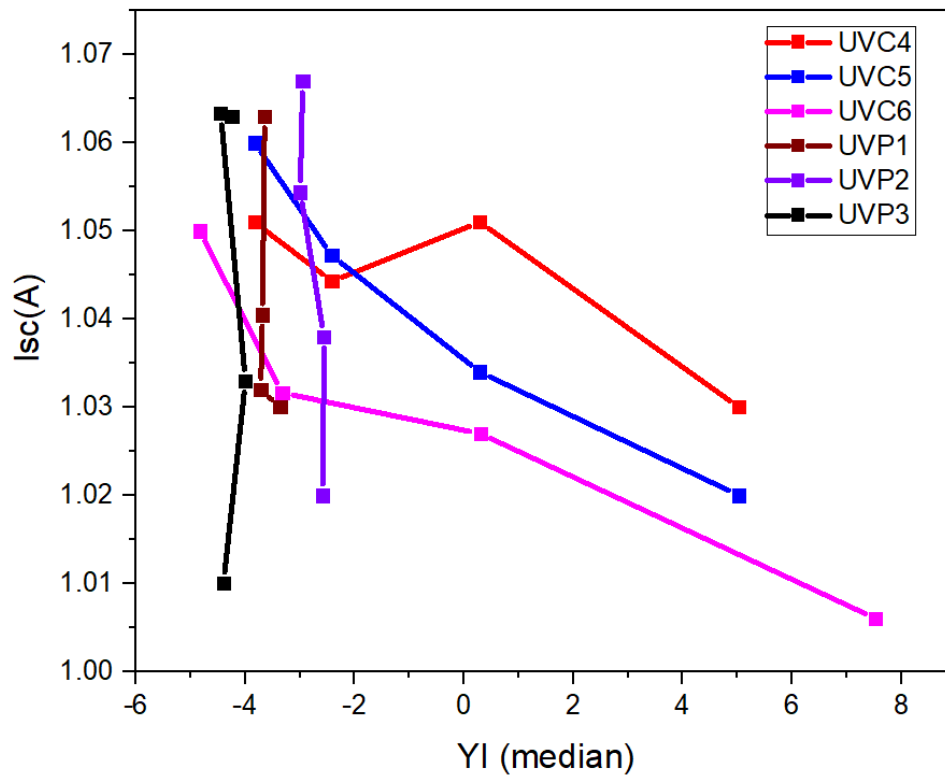
Figure 4.31: Isc vs YI plot for UVC and UVP modules at various stages of the dry accelerated stress test

Figure 4.31 shows the Isc vs YI plot for UVC and UVP modules at various stages for the modules in the dry run. In UVC the median Isc decreases with an increase in the value of YI. This is a clear indication that the decrease in short circuit current is because of the discoloration observed. In the UV Pass modules, the change in YI is minimal. This shows that the drop in the short circuit current is due to delamination.

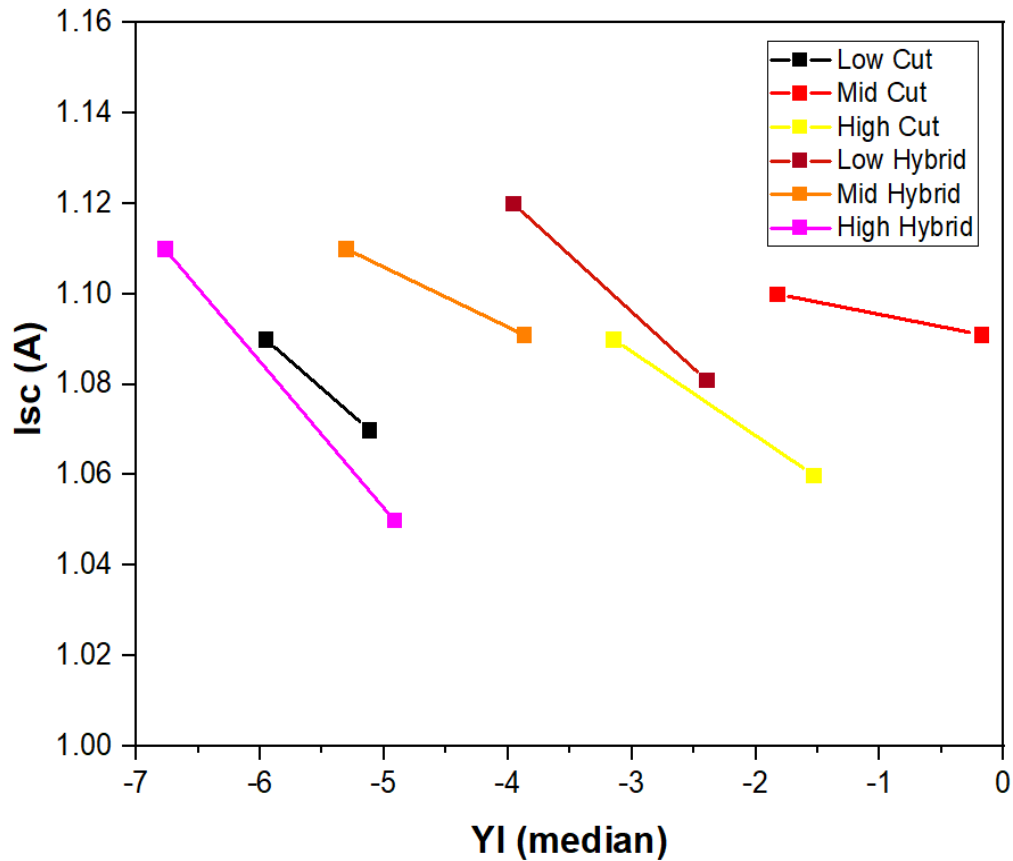
Figure 4.32: Isc vs YI plot for UVP modules at various stages of the humid accelerated stress test

For the humid run in *Figure 4.32* the values of the short circuit current decreases with an increase in the value of the YI. This indicates that the change in the material property of the EVA (loss in the transmission capacity due to discoloration) is the reason for the degradation in the short circuit current. In *Figure 4.32* the points in the top are at 0 kWh/m² and points in the bottom are after 186 kWh/m².

Moreover, a good linear relationship can be obtained if the I_{sc} is measured only in the browned region. In the above shown graphs the I_{sc} is measured for the entire cell which includes both the browned area and the bleached area along the periphery.

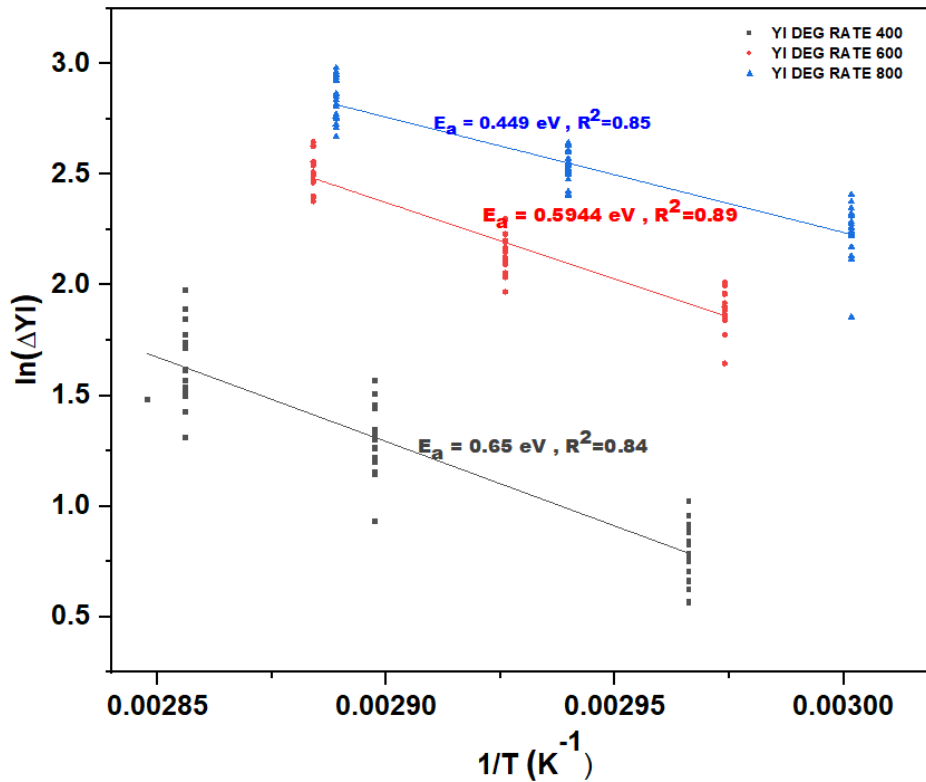
Figure 4.33: Activation energy with YI degradation rate at three different UV dosage each dosage having three different temperatures

For the dry run at dosage of 400kWh/m^2 , 600kWh/m^2 and 800kWh/m^2 the activation energy is calculated by plotting $1/T$ vs \ln (YI degradation rate). For this the YI degradation rate of all the cells at the two positions in the busbar are taken. Linear fit is done using origin and the parameters of regression coefficient is obtained. From the results the activation energy at 400 kWh/m^2 and 600 kWh/m^2 is 0.6 eV and E_a at 800 kWh/m^2 is 0.5 eV . At 800kWh/m^2 there is a drop in the activation energy showing that there might be an additional mechanism in addition to discoloration which is occurring at 800 kWh/m^2 dosage.

A decrease in activation energy was observed when the UV dosage was increased from 600 kWh/m² to 800 kWh/m². The reason for this decrease in activation energy is unknown but it could be due to the induction of an additional reaction along with the browning reaction.

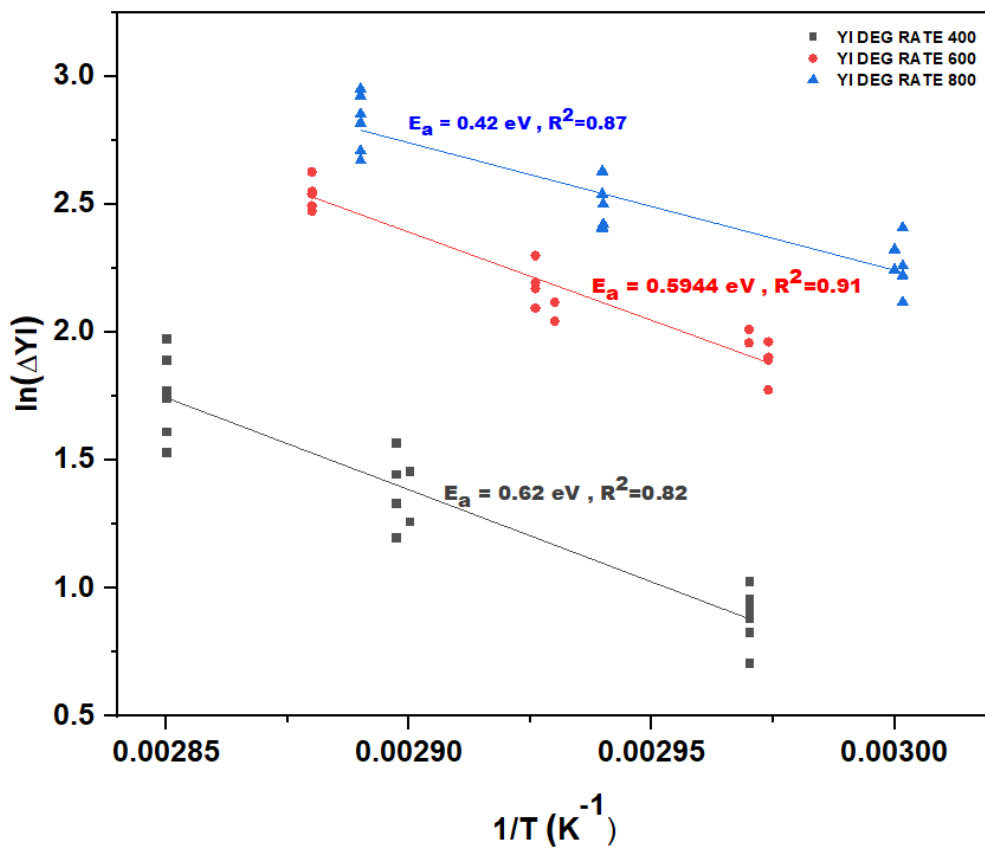
Figure 4.34: Activation energy with YI degradation rate at three different UV dosage each dosage having three different temperatures for the center cells (Cells 2,5,8)

By the mechanism suspected in Pg29, there is a possibility of the oxygen diffusing through the edges of the laminate. Hence the activation energy of all the cells will not give an accurate representation of the E_a for browning. To eliminate the possible bleaching effects and calculate the activation energy due to only browning, the corner cells are eliminated. The three cells in the center are considered for calculating the activation energy.
